Technical Memorandum

April 24, 2025

Cal Poly Humboldt – Humboldt Bay Aquatics Center – Asbestos and Lead Data Summary XPL286 – HBAC Balcony Replacement Project

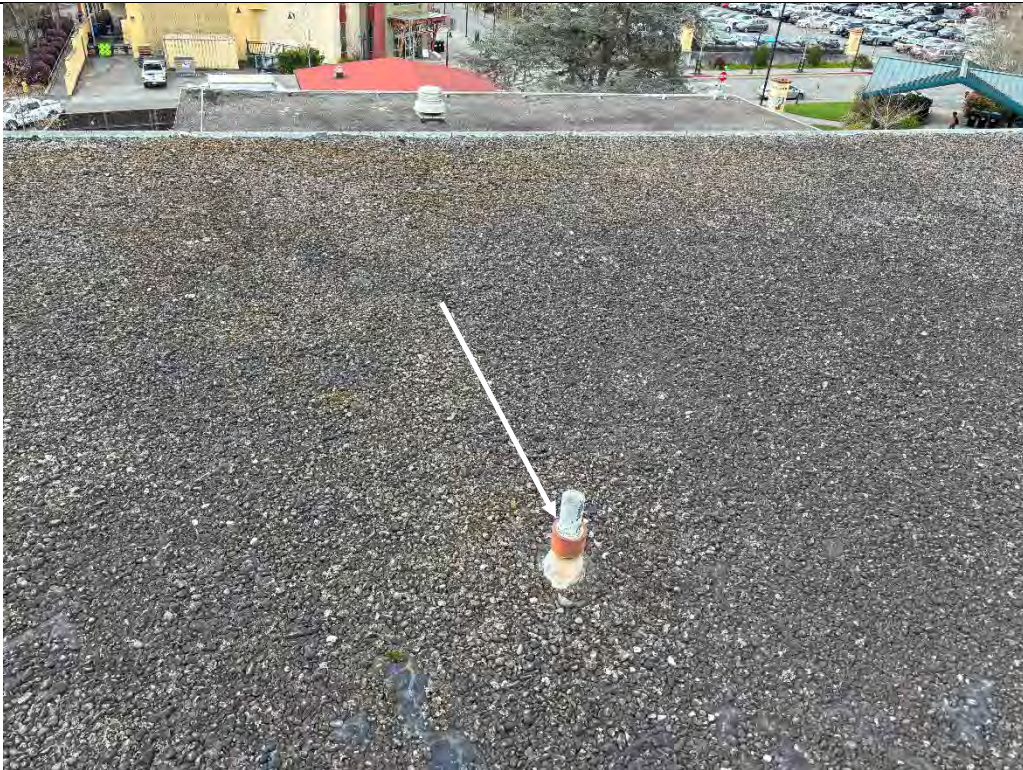
Photograph 8 – Exterior – Penthouse Balcony – Vent sealant reported to contain asbestos

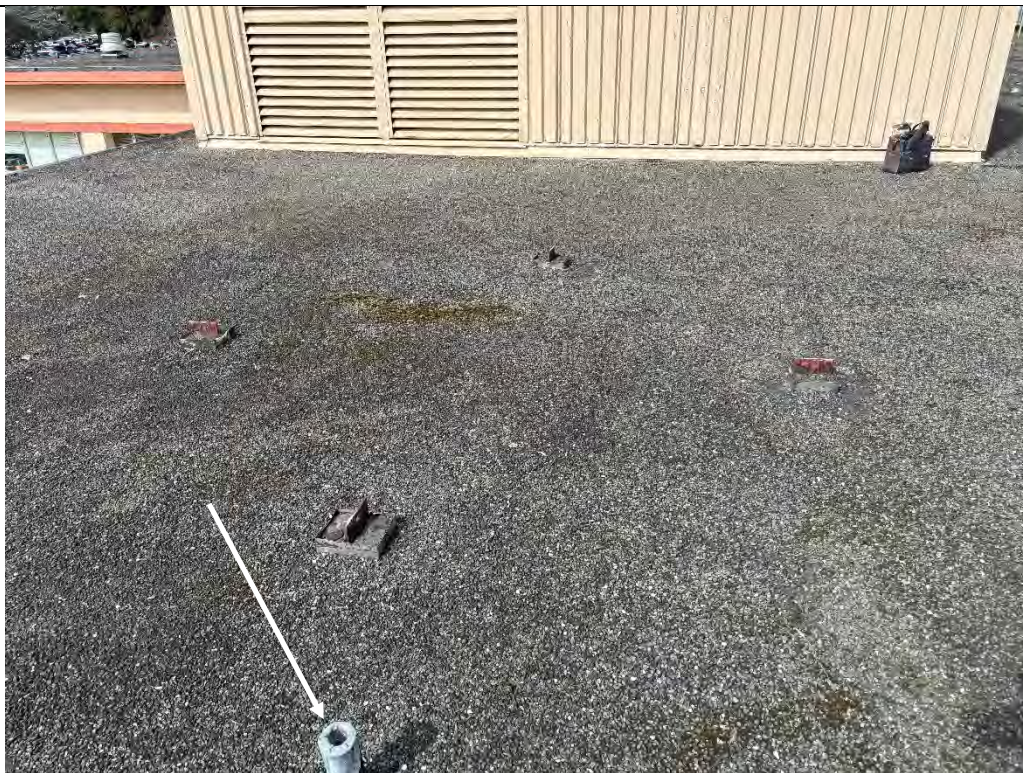
Photograph 10 – Humboldt Bay Aquatics Center – Exterior – Balcony – Vent flashing containing lead (typical)
