# Rapid Visual Screening of Buildings for Potential Seismic Hazards

## FEMA P-154 Data Collection Form

Address: 120 Science Lane  
Arcata, CA Zip: 95521  
 Other Identifiers: SFDB # 003A  
 Building Name: Science A - Addition  
 Use: Classroom, Faculty Offices, Labs  
 Latitude: 40.87534 Longitude: -124.07710  
 Ss: 2.93 S<sub>r</sub>: 1.82  
 Screener(s): Tim Josephs, Maryann Phipps Date/Time: 09/10/2021

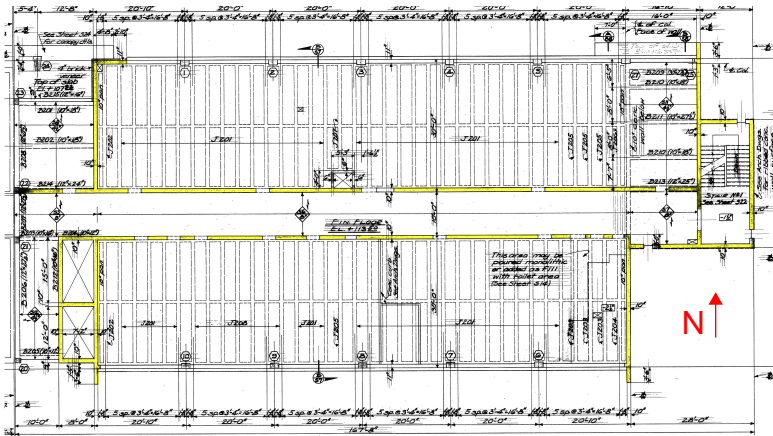
2ND FLOOR PLAN, CONCRETE SHEAR WALLS HIGHLIGHTED  
(1ST FLOOR SIM)

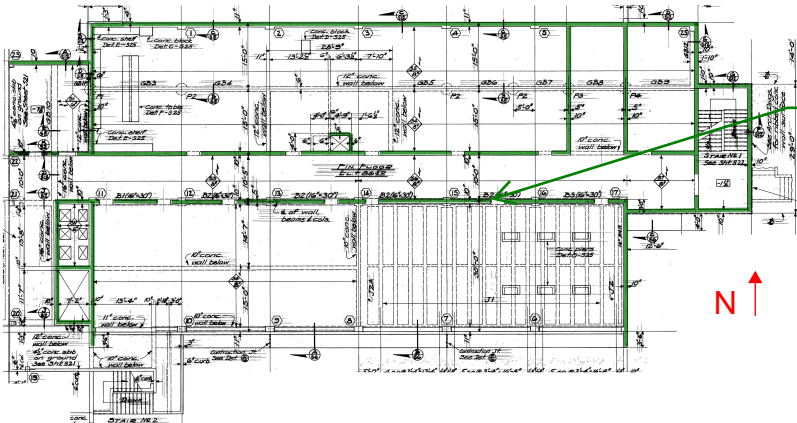
BASEMENT PLAN, CONCRETE SHEAR WALLS HIGHLIGHTED

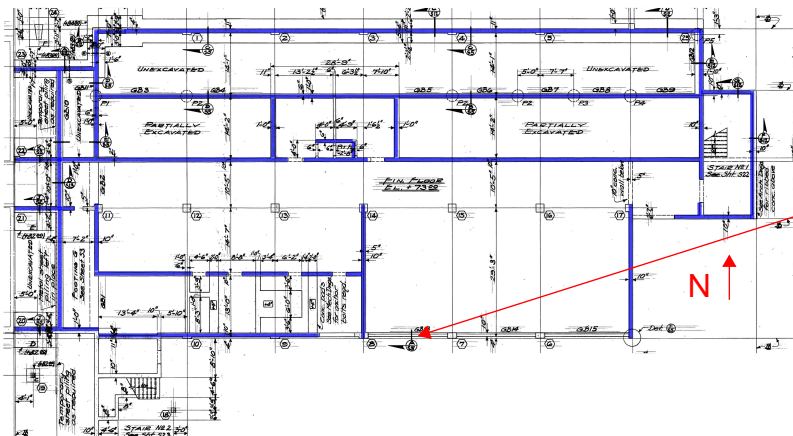
The lateral system consists of concrete slabs spanning to concrete shear walls. The site slopes one story level in the transverse direction. At the subbasement level, there is an out-of-plane setback as one corridor shear wall above does not have shear wall below.

SUB-BASEMENT PLAN, CONCRETE SHEAR WALLS HIGHLIGHTED

NOTE: THIS LINE OF WALL IS  
DISCONTINUOUS AT  
SUB-BASEMENT

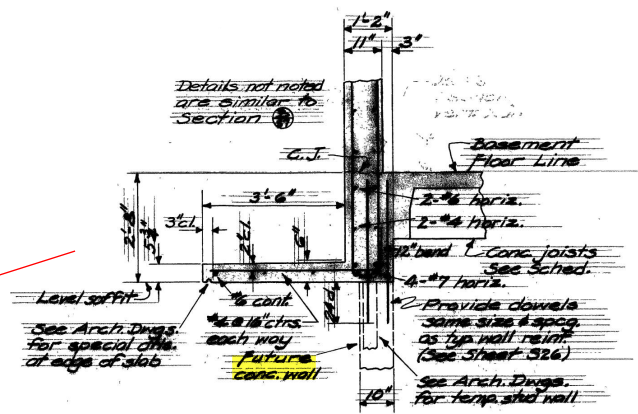
DETAIL SHOWING FUTURE WALL NOT  
BUILT AT SUB-BASEMENT LEVEL, TEMP  
STUD WALL STILL REMAINS

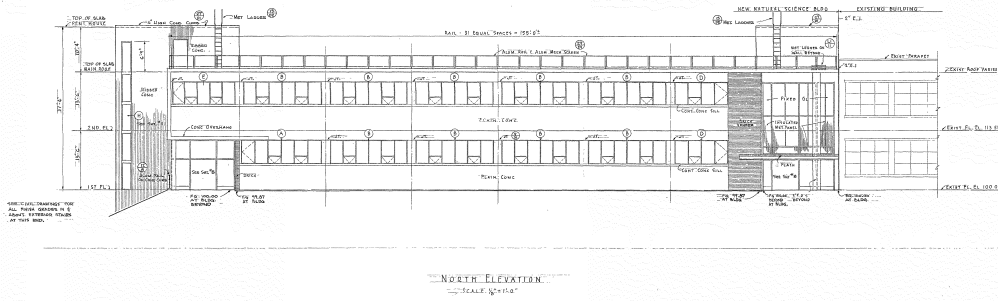
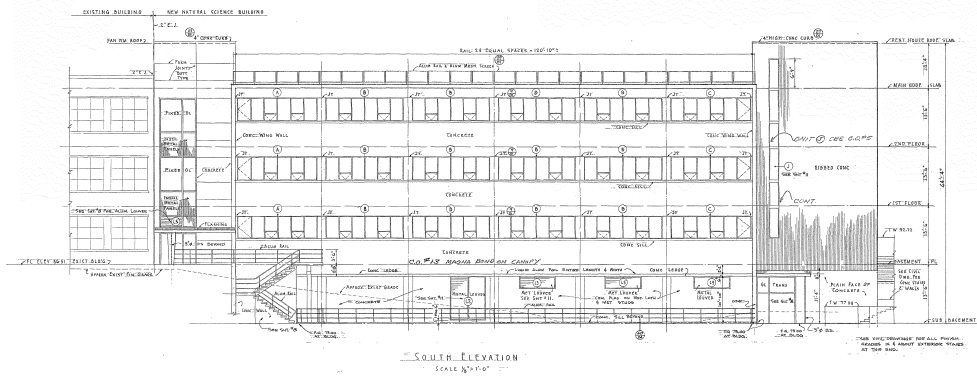
EXTERIOR ELEVATIONS

There is substantial amount of concrete shear wall along the double-loaded corridor and at the exterior transverse walls, and ample diaphragm to transfer load to them. The columns in the exterior column-spandrel frames are vulnerable to damage, however, because of the limited movement expected, the gravity load carrying capacity of the columns is expected to be maintained.
