Technical Memorandum

April 16, 2025

Cal Poly Humboldt Harry Griffith Hall – Asbestos and Lead Data Summary

XPL310 – Harry Griffith Roof Replacement Project

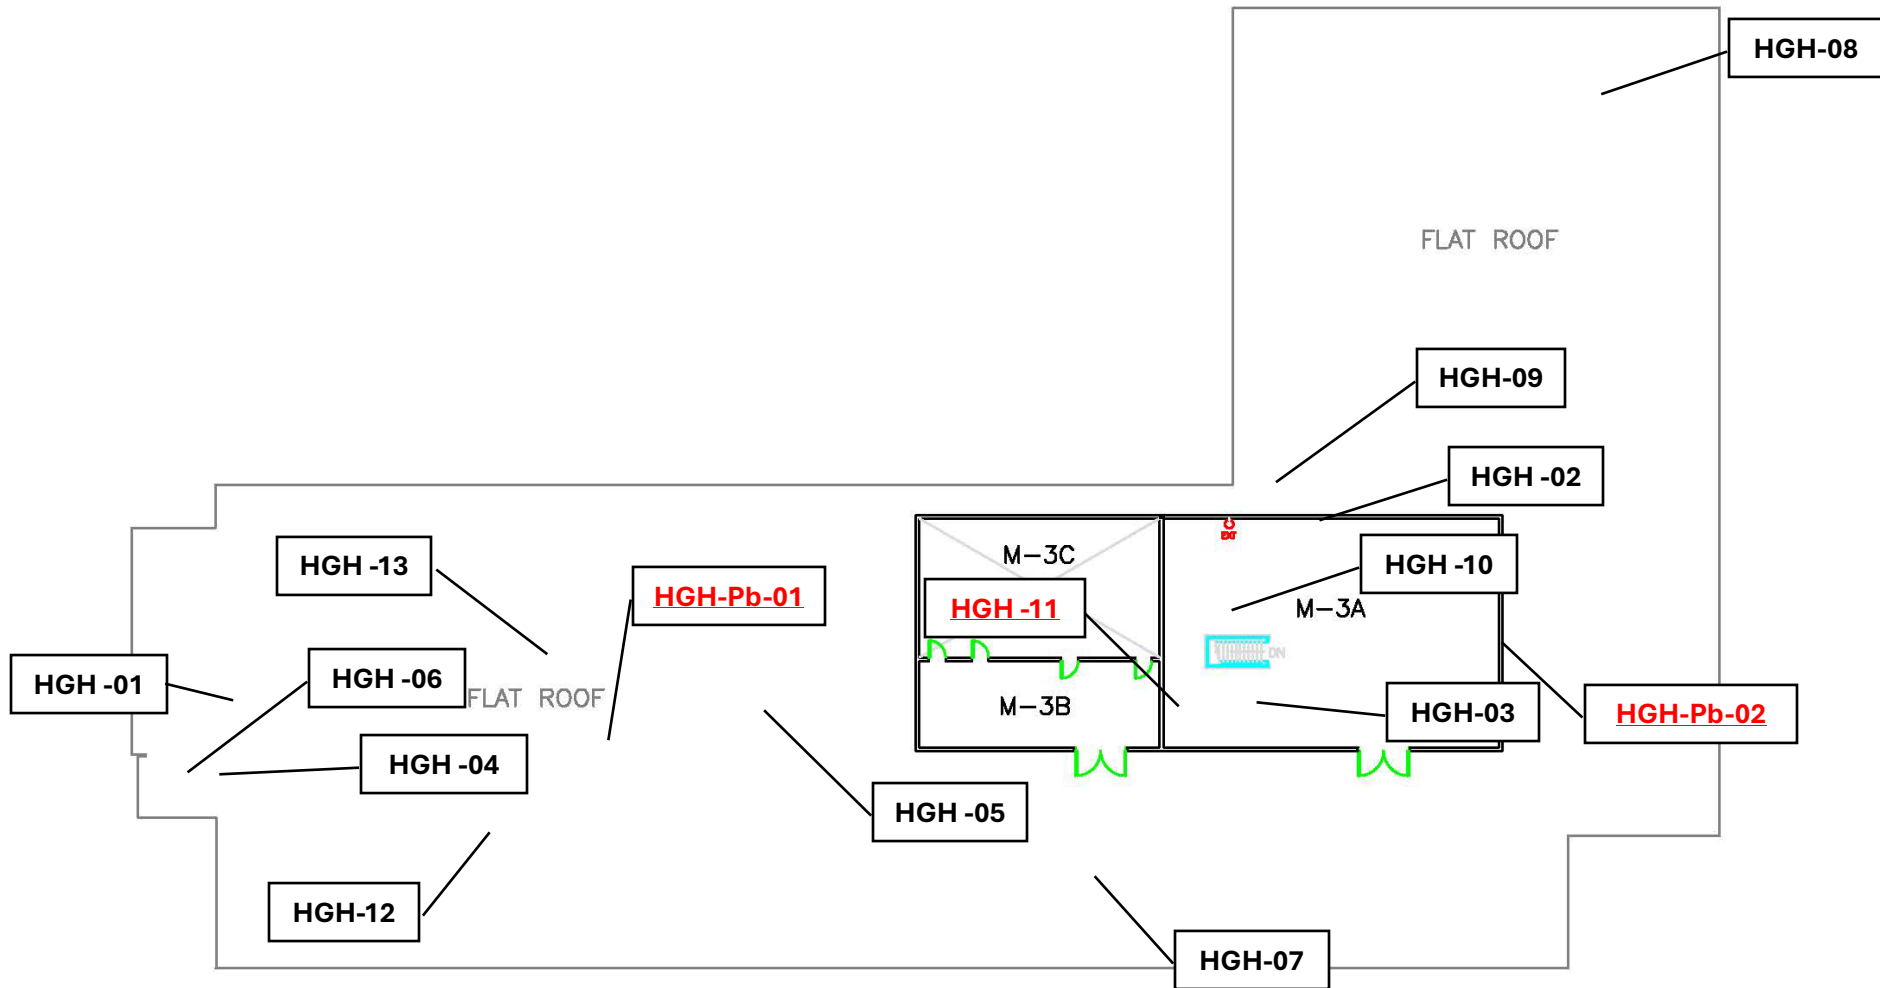
FIGURE 1 – SAMPLE LOCATION MAP
HARRY GRIFFITH HALL (004)
XPL310 - ROOF REPLACEMENT PROJECT

This memorandum summarizes the sampling survey analytical findings and provides conclusions based on these data. The location of samples collected at the HGH roof and the distribution of ACM and LBP identified onsite are depicted on the attached Sample Location Map (Figure 1, Attachment A).

A total 13 suspect ACM samples were collected throughout the HGH roof, some samples consisting of multiple unique layers of material. The samples collected at the HGH roof are listed in Table 1 (page 2). The sample locations are shown on Figure 1 (Attachment A).

As listed in Table 1, one (1) sample representing a single (1) homogeneous material was reported to contain asbestos. The location and quantity of the ACM identified at the HGH roof are shown on Figure 1 (Attachment A). Typical ACM located at HGH is shown in the attached photographs (Attachment B). The PLM laboratory analytical reports are attached (Attachment C).

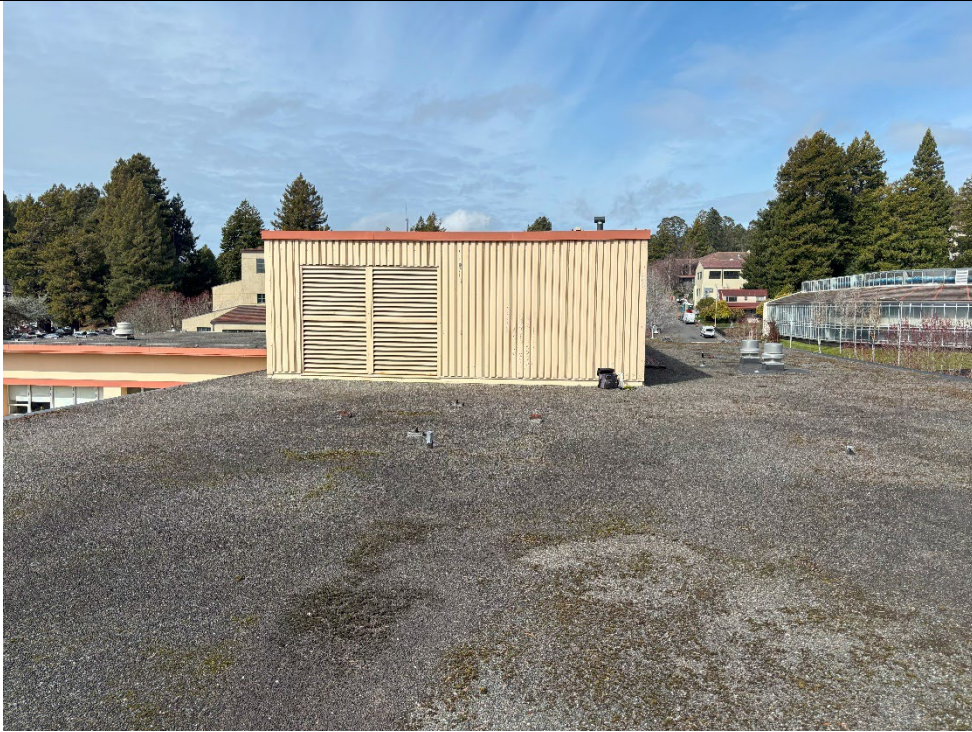
Photograph 1 – Harry Griffith Hall – Exterior – Roof – View looking north (penthouse south wall)

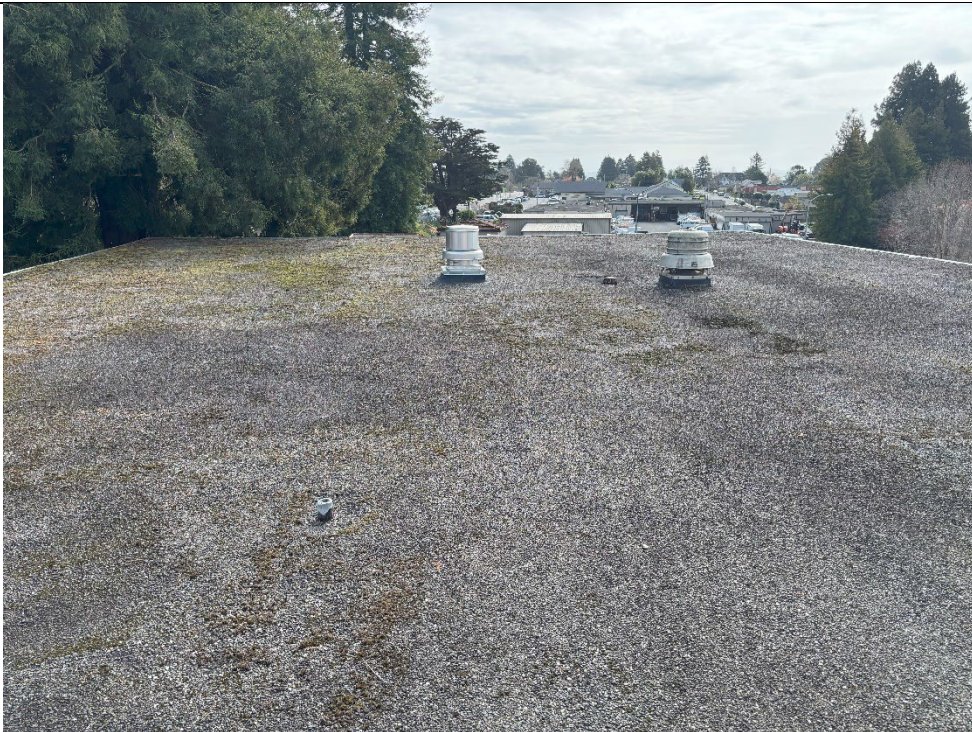
Photograph 2 – Harry Griffith Hall – Exterior – South Roof – View looking south

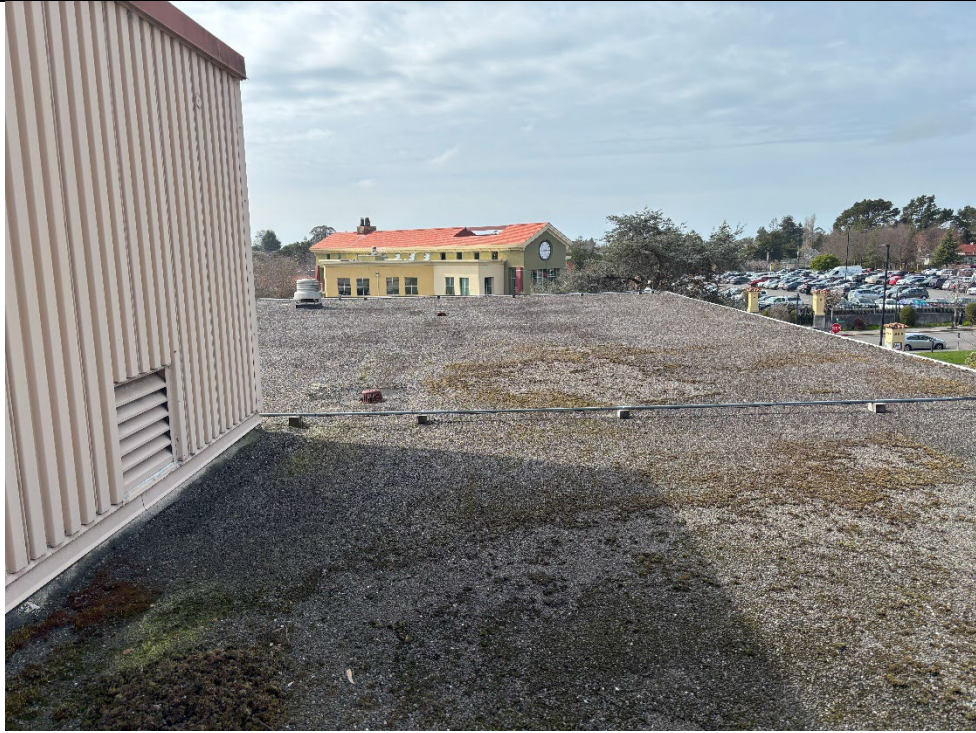
Photograph 3 – Harry Griffith Hall – Exterior – North Roof – View looking west

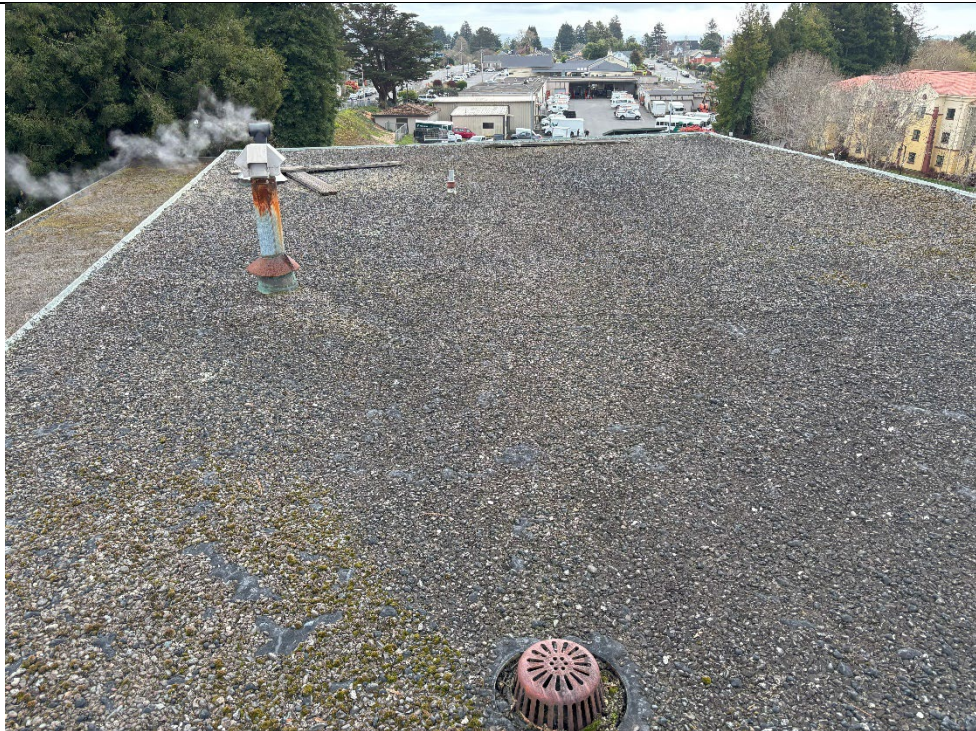
Photograph 4 – Harry Griffith Hall – Exterior – Penthouse Roof – View looking south

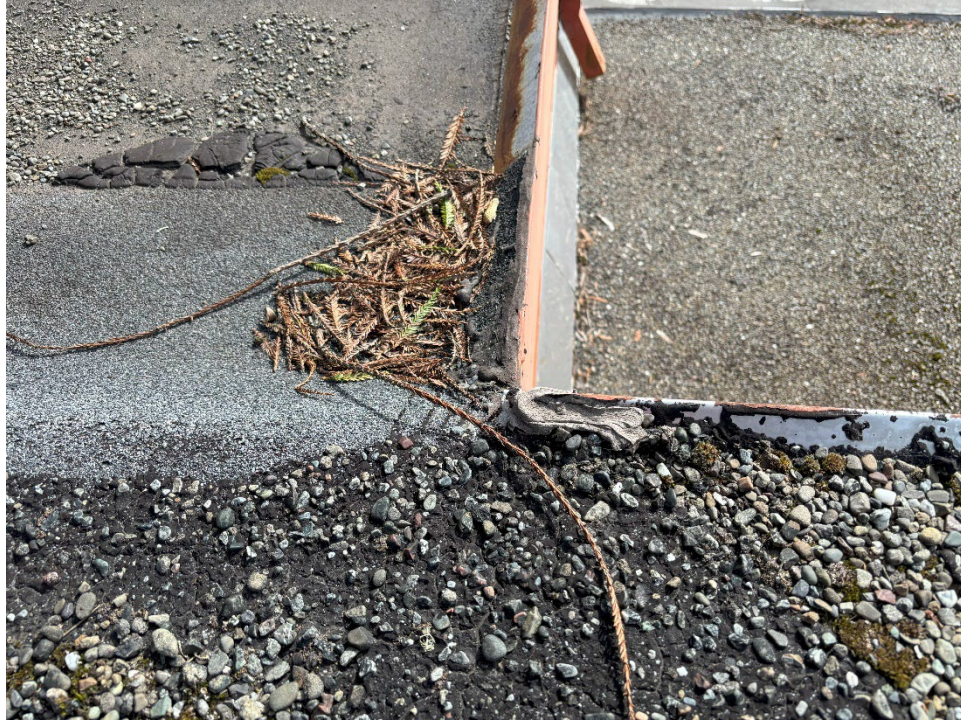
Photograph 5 – Harry Griffith Hall – Exterior – Roof – Transition to elevator shaft roof

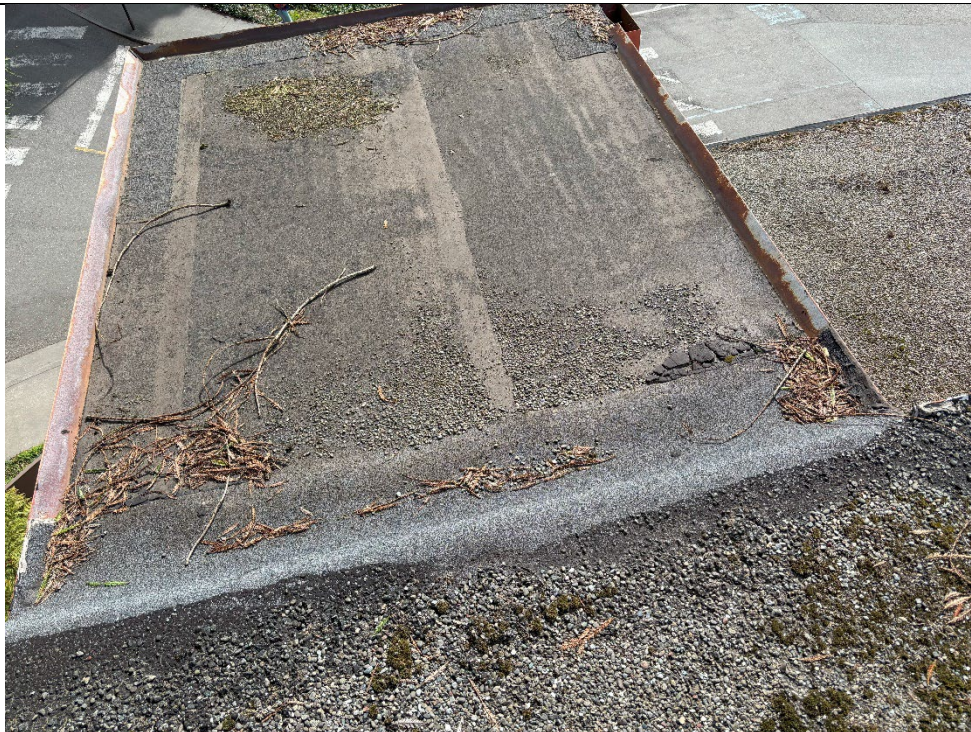
Photograph 6 – Harry Griffith Hall – Exterior – Roof – Elevator shaft and stairwell roof

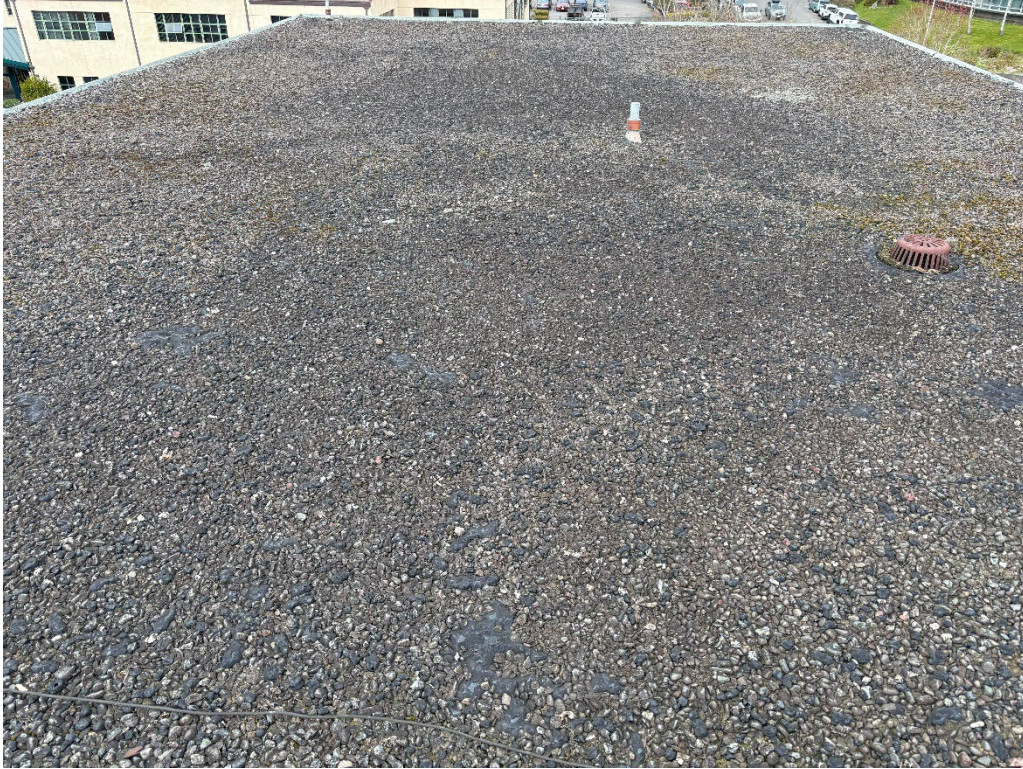
Photograph 7 – Harry Griffith Hall – Exterior – Penthouse Roof – View looking north

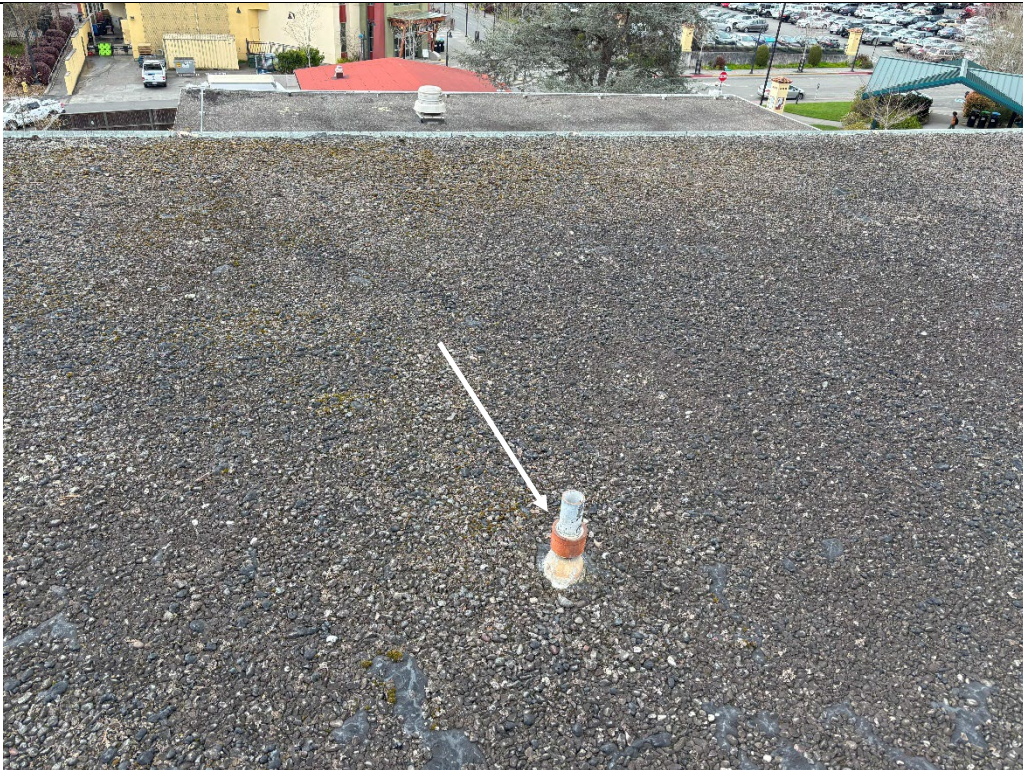
Nonfriable ACM is classified as nonhazardous asbestos waste, so long as the material is not rendered friable. If impacted using mechanical means, nonfriable ACM shall be understood to be rendered friable and reclassified as Regulated ACM (RACM). Friable material containing greater than one percent asbestos (RACM) is classified as a California hazardous waste.

Photograph 8 – Exterior – Penthouse Roof – Vent sealant reported to contain asbestos

Asbestos materials, if any, that may be disturbed by construction work at HGH shall be removed by a licensed abatement contractor prior to other work that may impact such material. Material containing greater than 1% asbestos is classified by Cal/OSHA as ACM, while material containing less than 1% asbestos is classified as ACCM. Construction work impacting ACM and ACCM requires compliance with Cal/OSHA asbestos regulations (8CCR1529). Demolition and renovation work impacting ACM requires compliance with the USEPA NESHAP regulations as enforced locally by the North Coast Unified Air Quality Management District (NCUAQMD).

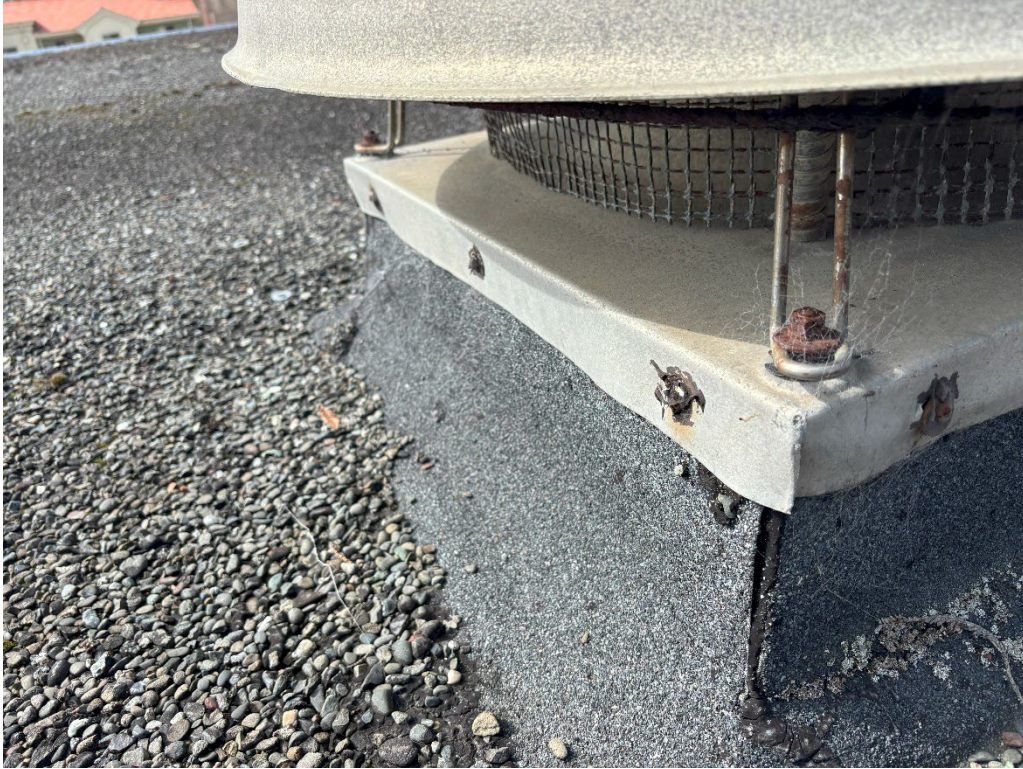
Photograph 9 – Harry Griffith Hall – Exterior – Roof – Vent flashing detail

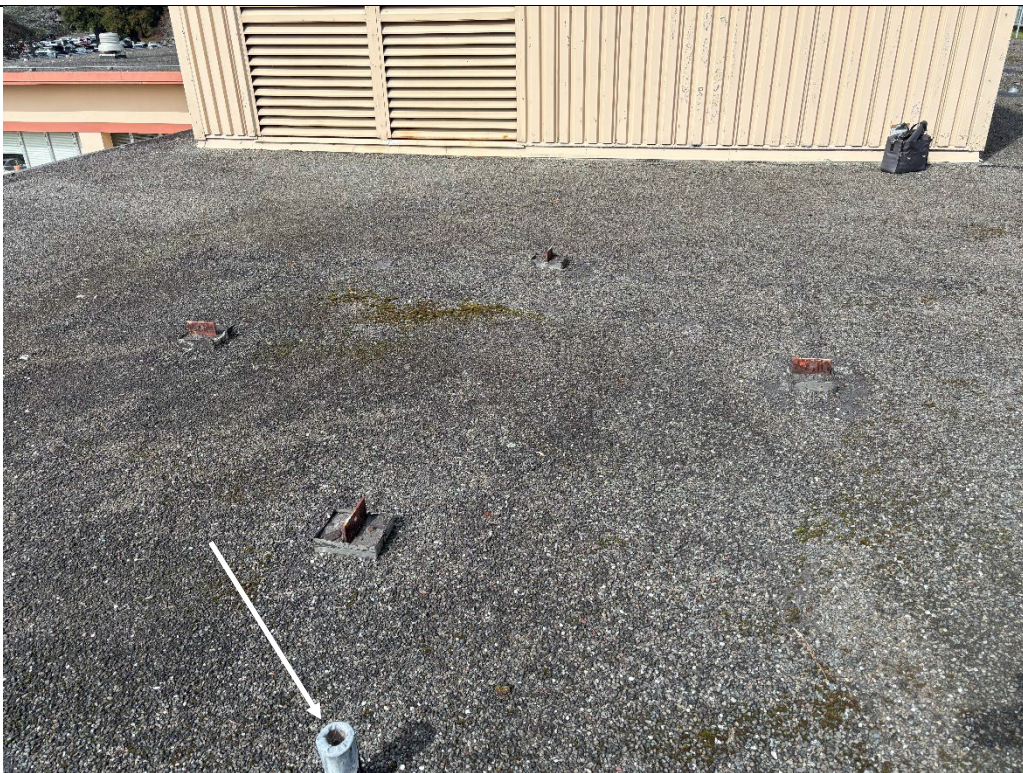
As noted in Table 2, two (2) samples representing two (2) unique materials were reported to contain lead. Paint reported to contain lead in concentrations greater than 5,000 parts per million (ppm) or 0.5% by weight is classified as LBP, while paint containing any detectable amount of lead is classified as Lead Containing Paint (LCP). Typical examples of the lead material identified at HGH is shown in the attached photographs (Attachment B). The AAS laboratory analytical reports are attached (Attachment C).

Photograph 10 – Harry Griffith Hall – Exterior – Roof – Vent pipe flashing containing lead (typical)

Based on the age of the building and data collected onsite, lead is known to be present at HGH. All painted coatings and malleable vent pipe flashing at HGH shall be presumed to contain lead unless sampled and proven otherwise. Construction work impacting known or presumed lead materials (e.g., LBP, LCP, etc.) must comply with applicable Cal/OSHA regulations (8CCR1532.1).
