Technical Memorandum

Cal Poly Humboldt Siemens Hall – Asbestos and Lead Data Summary

XPL311 – Siemens Hall Roof Replacement Project

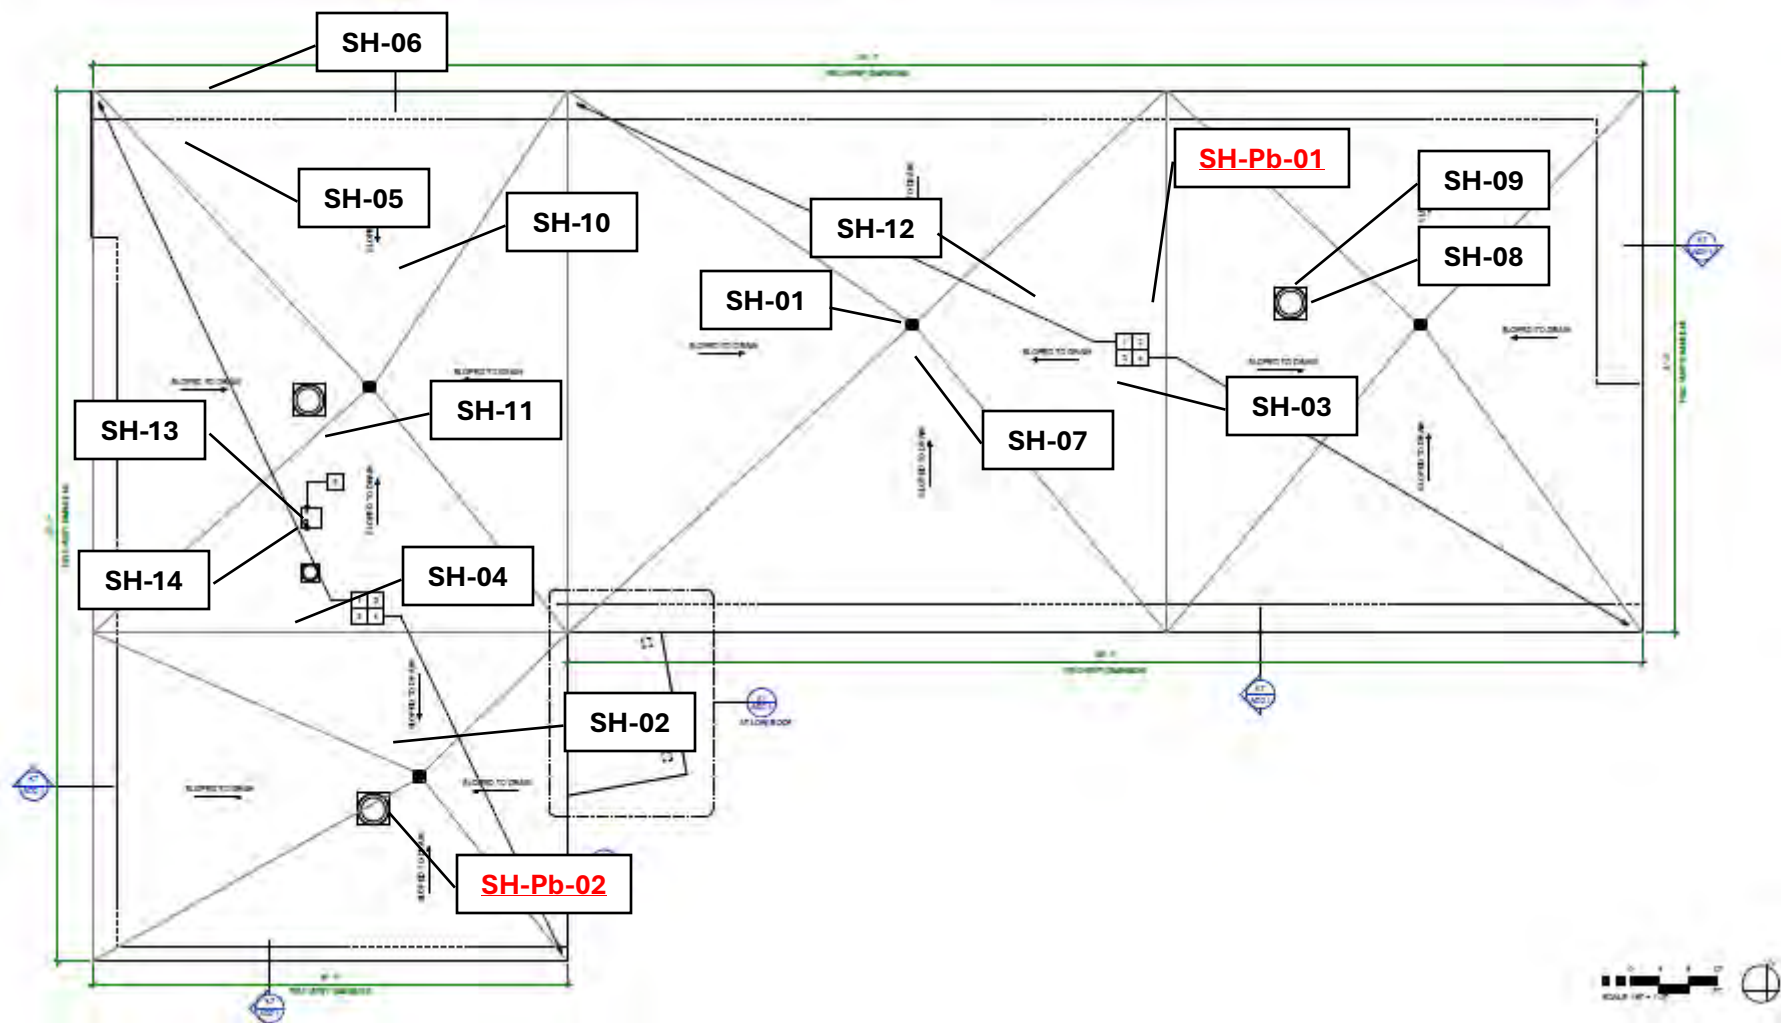
FIGURE 1 – SAMPLE LOCATION MAP
SIEMENS HALL (001)
XPL311 - ROOF REPLACEMENT PROJECT

As listed in Table 1, none (0) of the sampled materials were reported to contain asbestos. The location of the samples collected at the SH roof are shown on Figure 1 (Attachment A). Typical sampled materials are depicted in the attached photographs (Attachment B). The PLM laboratory analytical reports are attached (Attachment C).

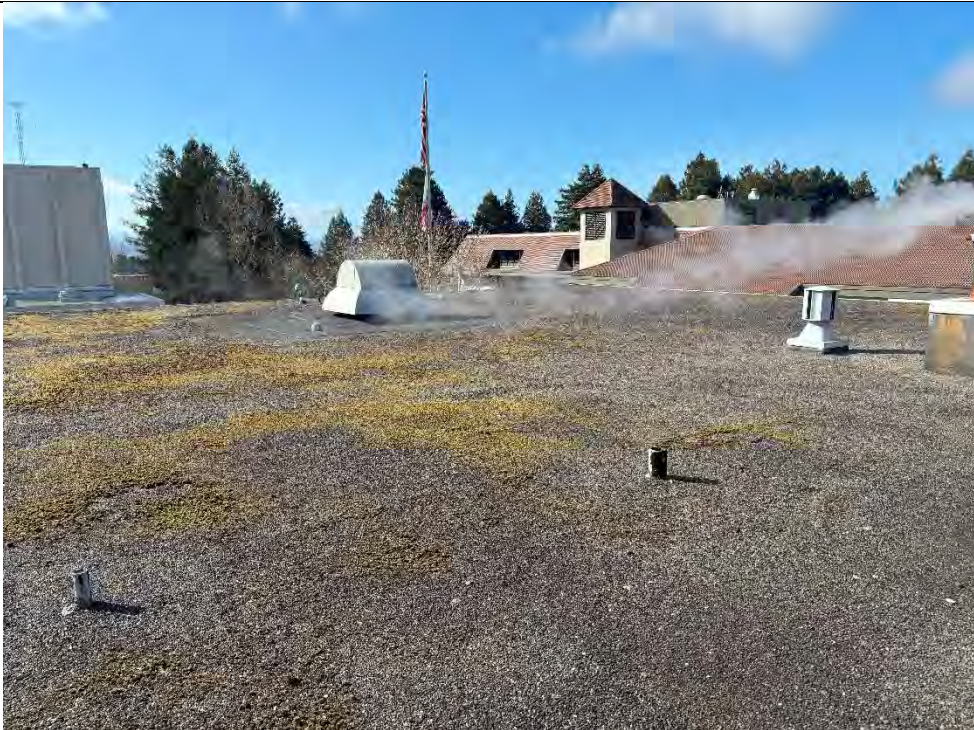
Photograph 4 – Siemens Hall – Exterior – Roof – View looking southwest – Built-up roofing (typical)

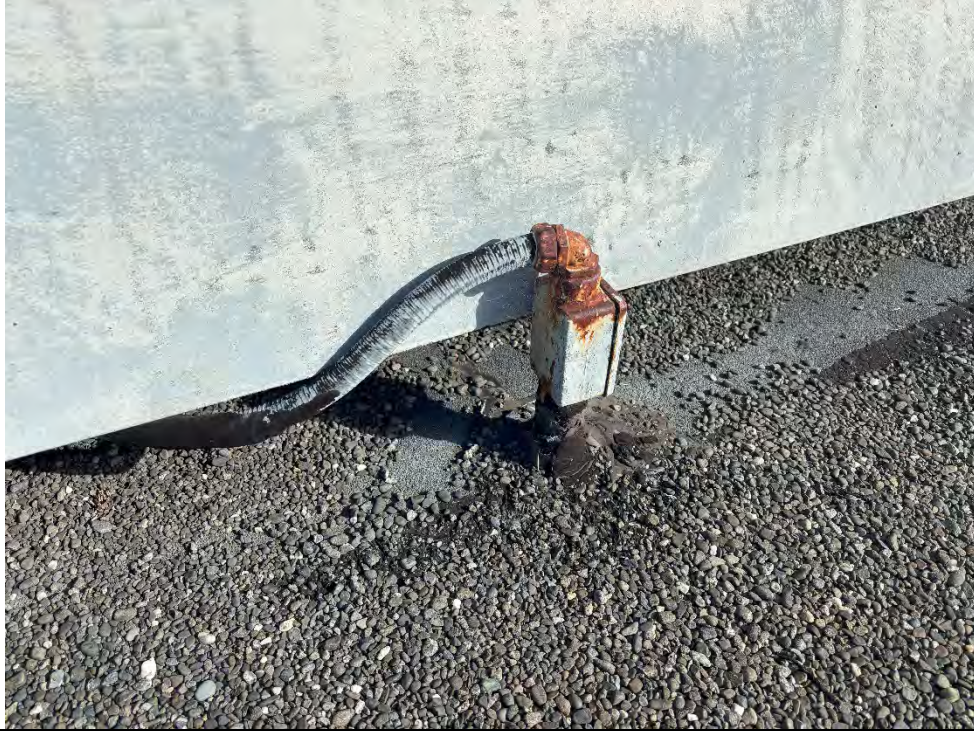
Photograph 5 – Siemens Hall – Exterior – Roof – Penetration mastic (black) (typical)

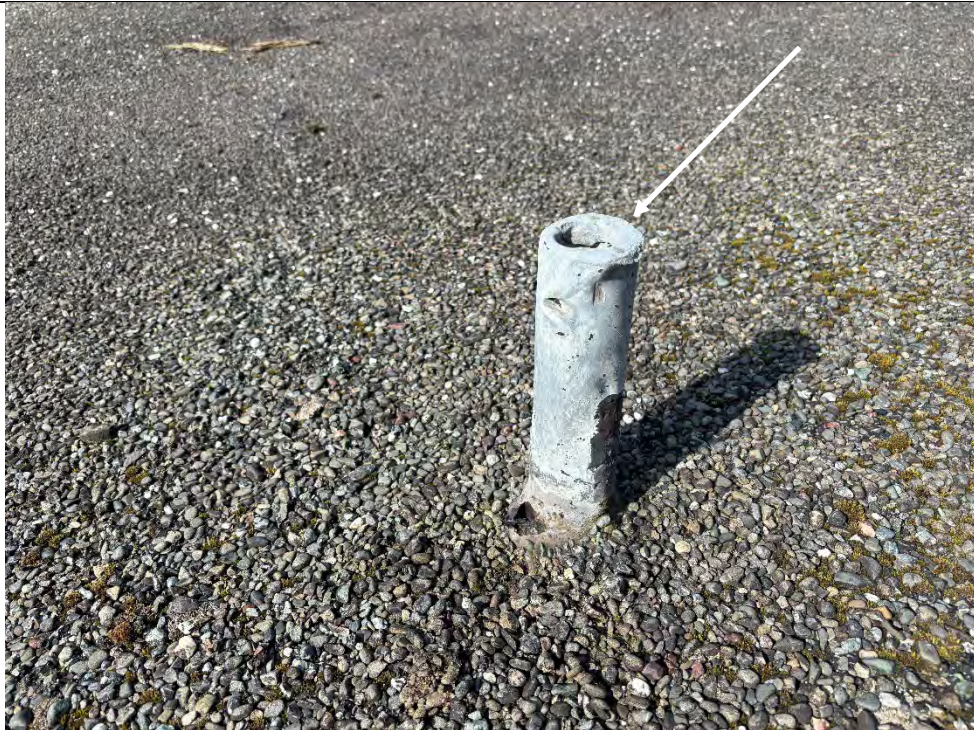
As noted in Table 2, two (2) samples representing two (2) unique materials were reported to contain lead. Paint reported to contain lead in concentrations greater than 5,000 parts per million (ppm) or 0.5% by weight is classified as LBP, while paint containing any detectable amount of lead is classified as Lead Containing Paint (LCP). Typical examples of the lead material identified at SH is shown in the attached photographs (Attachment B). The AAS laboratory analytical reports are attached (Attachment C).

Photograph 6 – Siemens Hall – Exterior – Roof – Vent pipe flashing containing lead (typical)

Based on the age of the building and data collected onsite, lead is known to be present at SH. All painted coatings and malleable vent pipe flashing at SH shall be presumed to contain lead unless sampled and proven otherwise. Construction work impacting known or presumed lead materials (e.g., LBP, LCP, etc.) must comply with applicable Cal/OSHA regulations (8CCR1532.1).

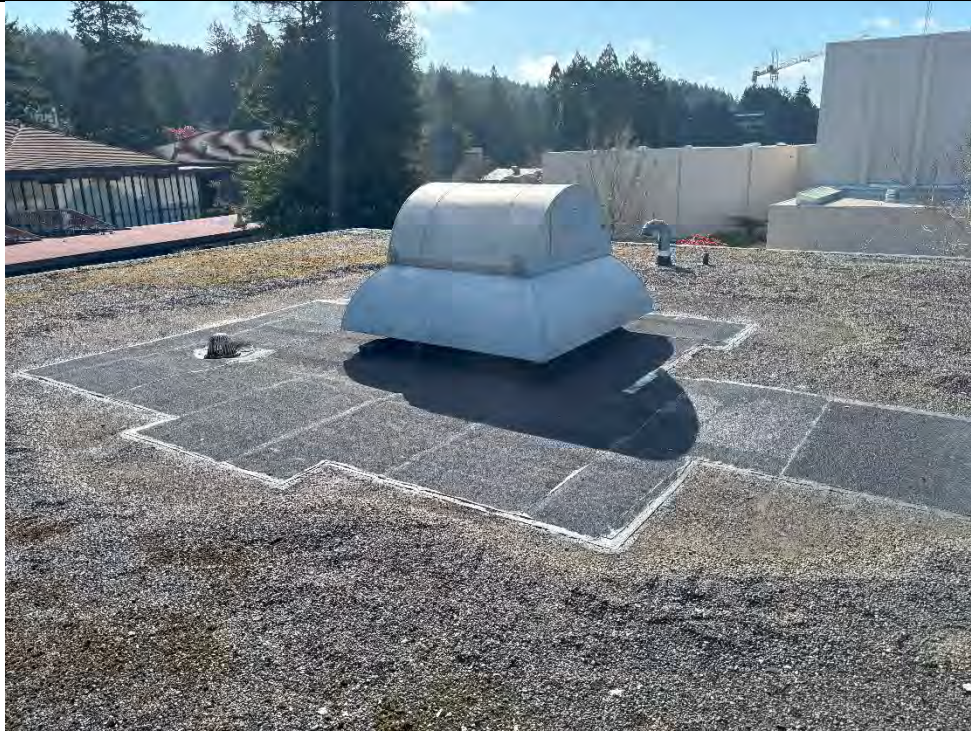
Photograph 7 – Siemens Hall – Exterior – Roof – Rolled roofing patch at southwest-center

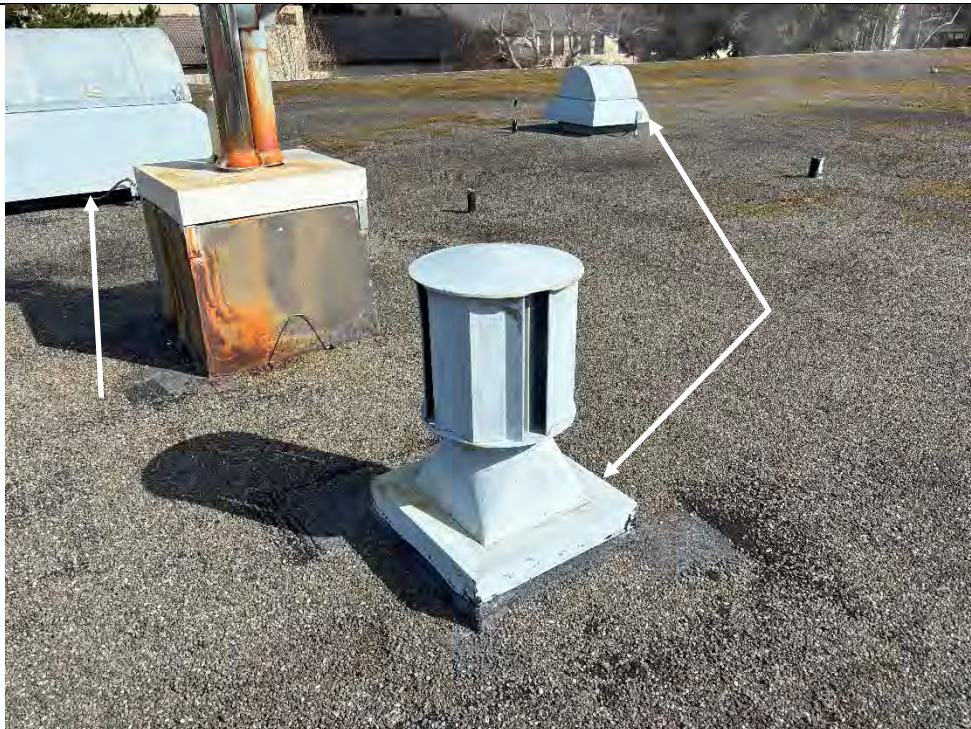
Photograph 8 – Exterior – Roof – HVAC vent housing paint (grey) containing lead (typical)

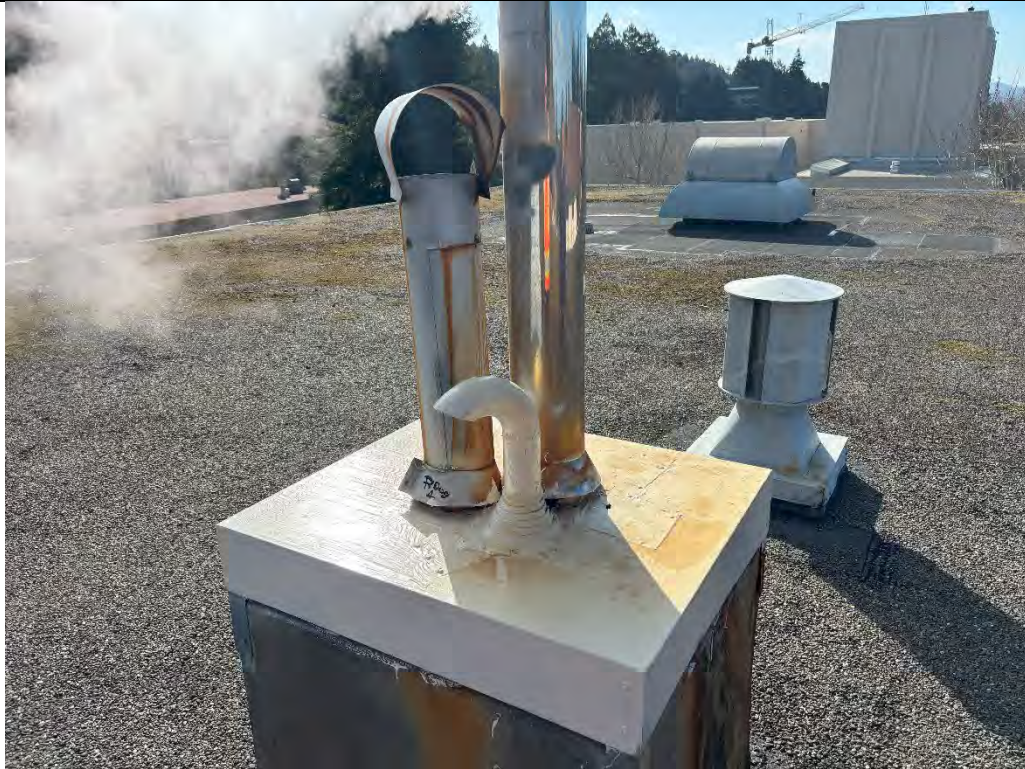
Photograph 9 – Siemens Hall – Exterior – Roof – Vent curb, flashing

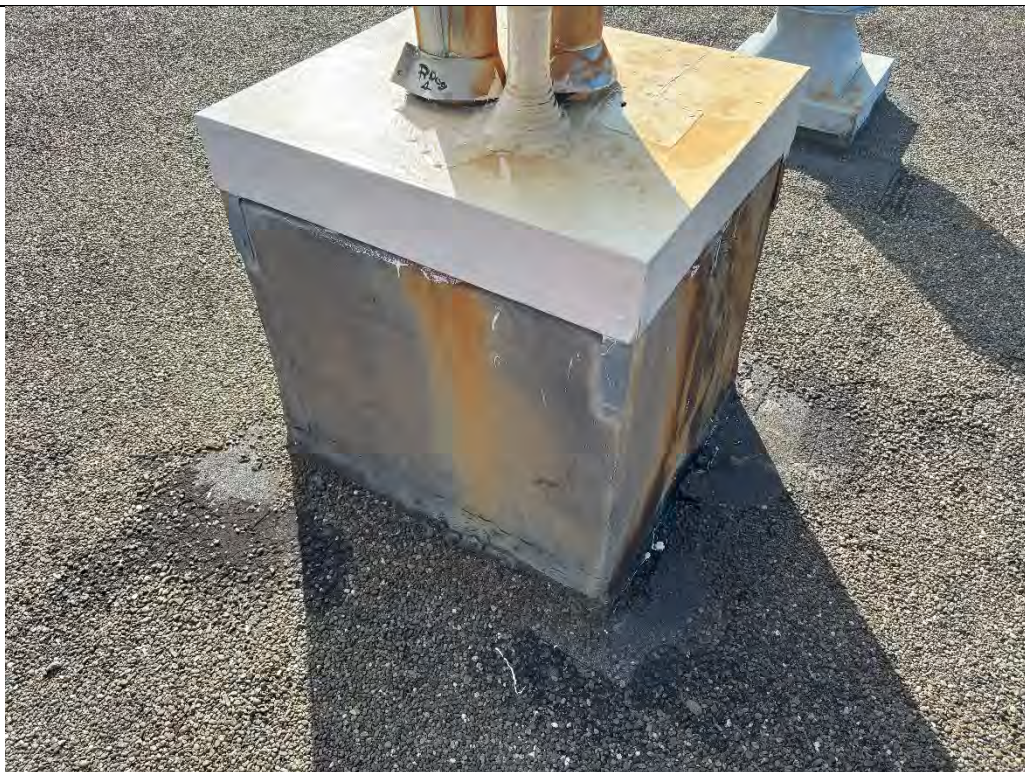
Photograph 10 – Siemens Hall – Exterior – Roof – Vent curb epoxy coating (black)
