Independent Seismic Review and Concept Retrofit Design

Stewart Building 1125 16th Street Arcata, CA

Performed for Compliance with CSU
Seismic Requirements

Maryann T. Phipps
Megan E. Doxzen
Benjamin Biddick
January 31, 2025

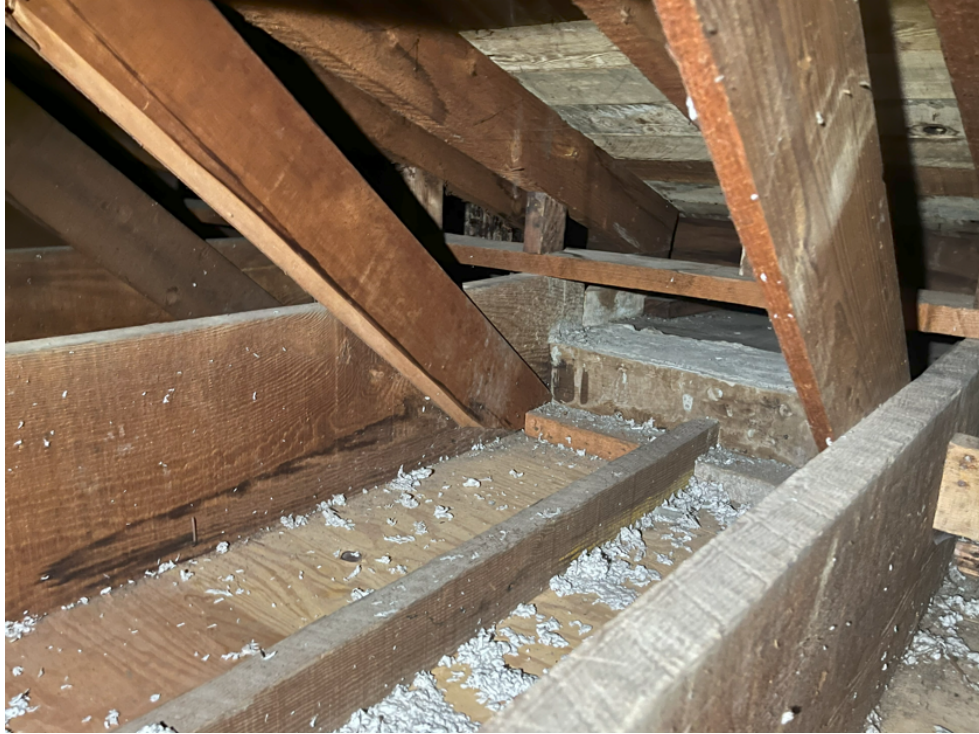
The 1x straight-sheathed main roof diaphragm spans between the concrete walls. There is a 1'-2" gap between the diaphragm and the top of the concrete walls (Figure 8). Due to the attic diaphragm discussed below, the main roof diaphragm is only required to transfer its own self-weight to the walls.

Figure 8 – Main roof at exterior concrete wall with attic framing below.

- Transfer of in-plane loads from flexible diaphragms to shear walls: At the sloped high roof, the cripple walls cannot adequately transfer shear to the concrete walls. At the main roof, the 1'-2" gap between the diaphragm and the top of the concrete walls indicates there is no load path to deliver in-plane shear to the concrete walls.

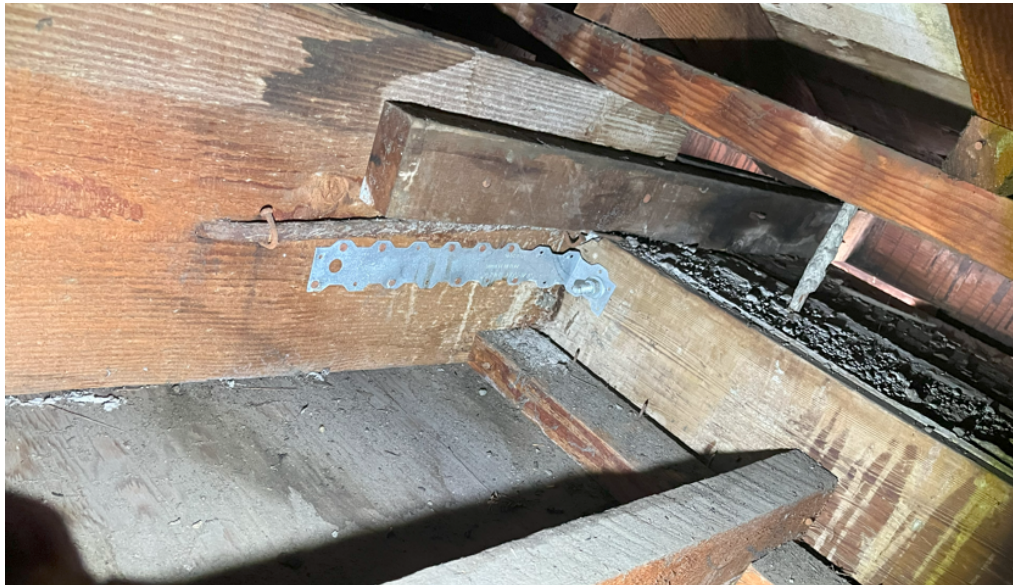
Figure 9 – Out-of-plane wall anchored to attic joist with plywood below.

- Out-of-plane wall anchorage at flexible diaphragms: The observed anchorage at the attic and second floor diaphragms is insufficient to reliably brace the concrete walls out-of-plane.

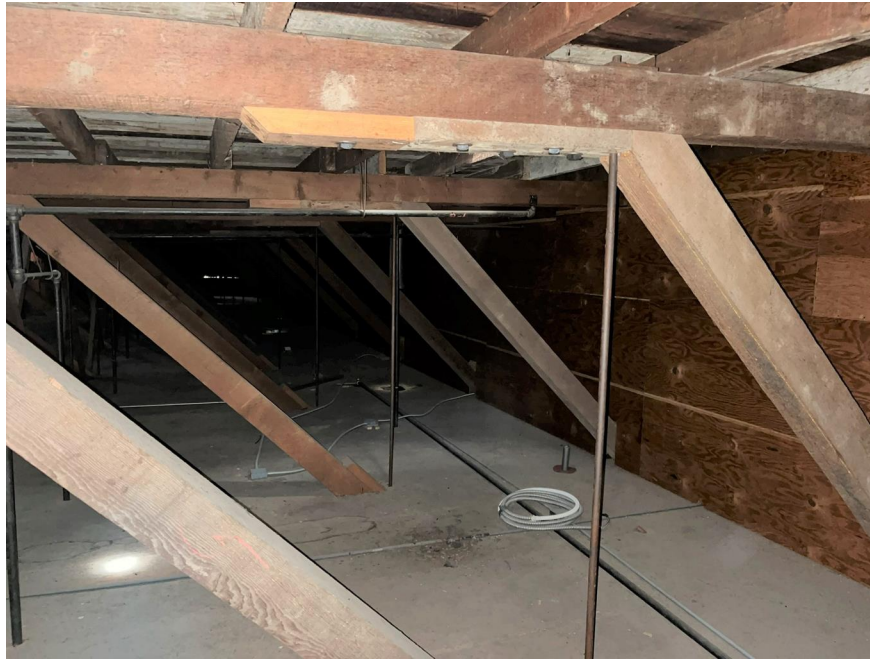
There is evidence of seismic upgrading in the attic space. Below the main roof, a plywood diaphragm at the underside of the attic joists connects to the perimeter and interior concrete walls. The diaphragm is blocked, has approximately 5" on center edge nailing, and has infrequent metal straps and anchors tying the diaphragm and concrete walls together (Figure 9). Below the high roof, east-west plywood shear walls connect the high roof diaphragm to an intermediate plywood diaphragm just below the top of the concrete walls on three sides (Figure 10). On the north side, where there is not a concrete wall, there appears to have been some effort to tie the plywood diaphragm into the full-height, straight-sheathed wood wall (Figures 5 and 6).

Figure 10 – Plywood walls and diaphragm below high roof

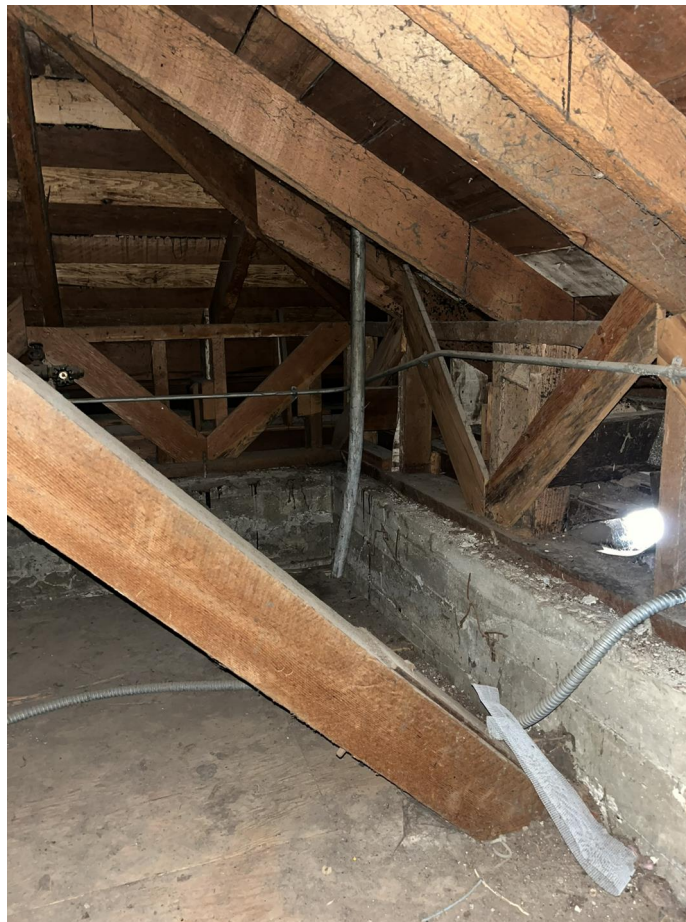
Where the high roof slopes to meet the top of the concrete walls, short wood-framed cripple walls sit on top of the concrete walls and are braced with 1x diagonal straps. The wood sill plate is punctured by the 3/8" square bars where they occur (Figure 11).

Figure 11 – Cripple wall with diagonal bracing on top of concrete wall at high roof

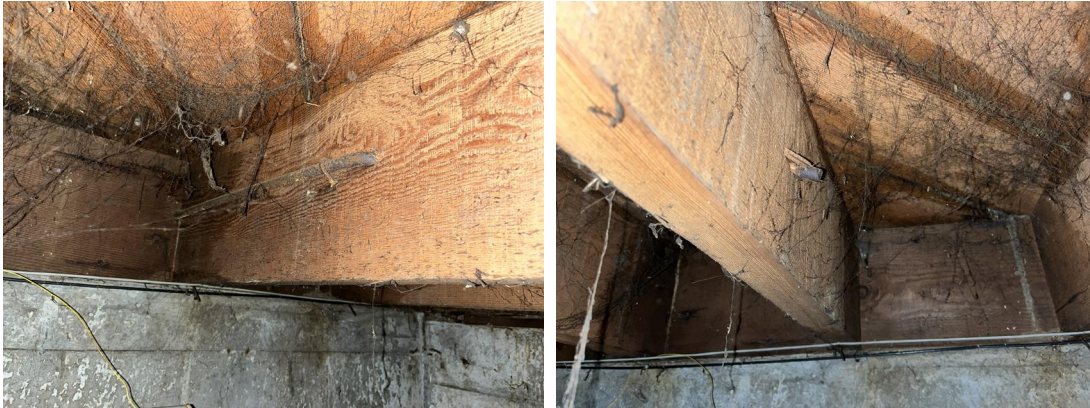
At the second floor, the diaphragm is tied into the walls with 1/2" diameter bars extending out of the concrete wall and bent through the joists (aka "government anchors"). The bars were observed to be spaced at 64" located only on the sides where the joists are perpendicular to the concrete walls (Figure 12).

Figure 12 – Rebar extending out from the concrete wall and hooked through a second floor joist

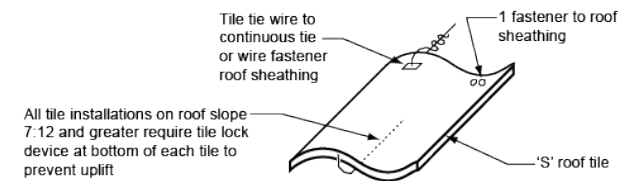
12 SECURING CLAY TILES
NOT TO SCALE

- Continuous cross ties between diaphragm chords: Continuous cross ties were not found at joist splices.
- Falling hazards: The clay tiles are not positively attached to the roof sheathing.

- Out-of-plane wall anchorage at flexible diaphragms: Additional concrete anchors will be installed to brace the concrete walls to the attic and second floor diaphragms.
- Transfer of in-plane loads from flexible diaphragms to shear walls: At the high roof, plywood sheathing will be installed on the cripple walls below the high roof. At the main roof, the 1'-2" gap will be filled with plywood blocking fastened to the straight sheathing above and the concrete wall below.
- Wood diaphragm spans: New plywood shear walls will be installed at the first floor in the north-south direction to reduce the second floor diaphragm spans.
- Continuous cross ties between diaphragm chords: Tension ties will be installed at joist splices at the attic and second floor diaphragms.
- Falling hazards: Tie wires will be installed through each clay tile and fastened to the roof sheathing.
