**CALIFORNIA POLYTECHNIC UNIVERSITY,
HUMBOLDT**

HEALTHCARE HUB

STEWART BUILDING ASSESSMENT

June 5, 2025

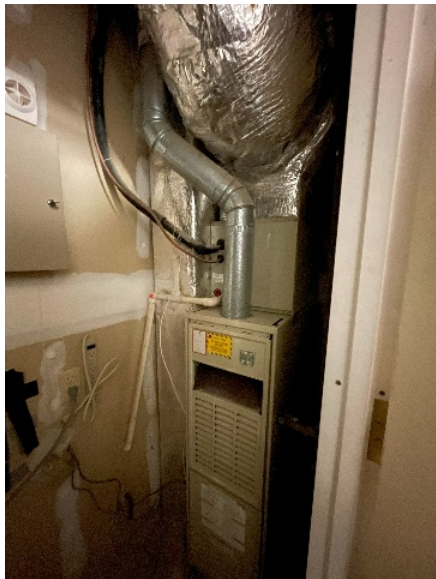
The furnace units are of varying condition and age, however all are either past their working life or sized only to meet demands of the spaces they currently serve.

Figure 1. Furnace In Level 1 Art Studio

Given the visible condition of all existing HVAC equipment, it is beyond its anticipated service life and shall be replaced as part of retrofit work. Refer to the recommendations section for proposed improvements.

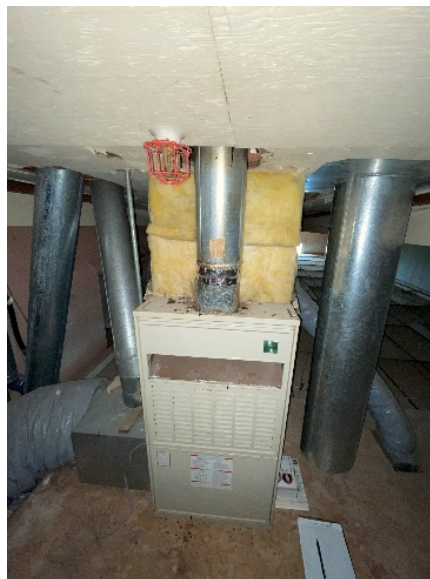
Figure 2. Furnace Above Room 213A Ceiling

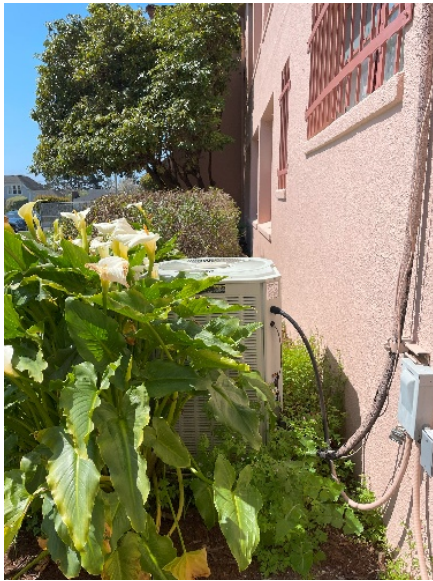
The same condensing 5-ton Trane condensing unit mentioned above located to the south side of the building is assumed to be provided to meet latent and sensible cooling requirements of the physical therapy studio. There is no other visible cooling provided at the building.

Figure 3 Condensing Unit Location

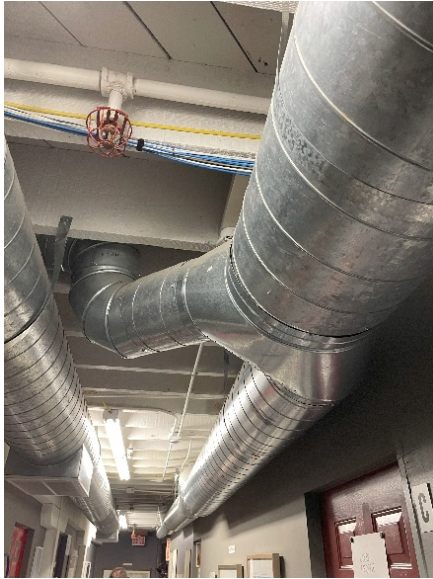
Ducting on the East side of Level 1 is largely exposed galvanized steel ducts from cupboard mounted vertical furnaces to the various individual studios. Ductwork at this level appears to be more recently installed and in better condition than Level 2, and has some potential for reuse, should this space remain in scope and not require demolition. Ducting on the West side of Level 1 is concealed above acoustic ceiling tiles and was not inspected; however, it is expected to be at end of life and unfit to be retained once the ceiling has been demolished to suit the new program needs.

Figure 5. Level 1 Corridor Duct Main

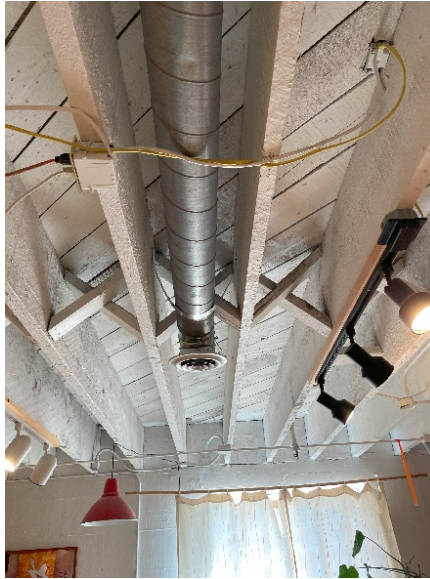
Figure 6. Level 1 Art Studio Duct and Diffuser

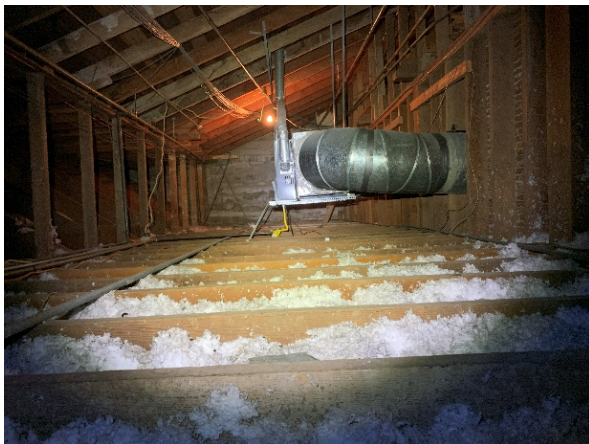
Ducts on Level 2 from HVAC units to ceiling-mounted air diffusers are mostly routed through the attic space (accessed via hatches in level 2 main corridor ceiling). This space appears sufficient for future ducting, piping and terminal units where required, however some structural and architectural modifications may be required to permit proper maintenance access.

Figure 7. HVAC Unit in Attic above Central Corridor

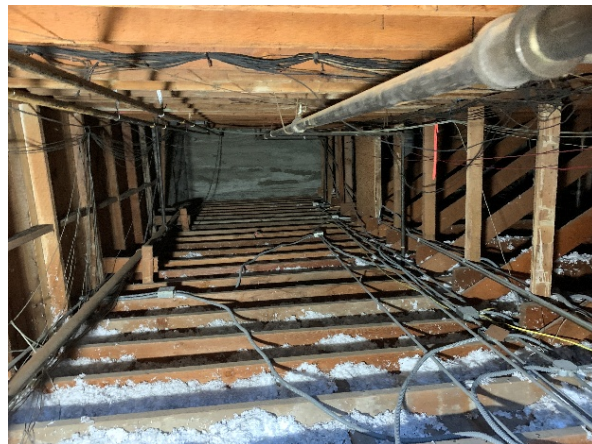
Figure 8. Attic Space above East Corridor

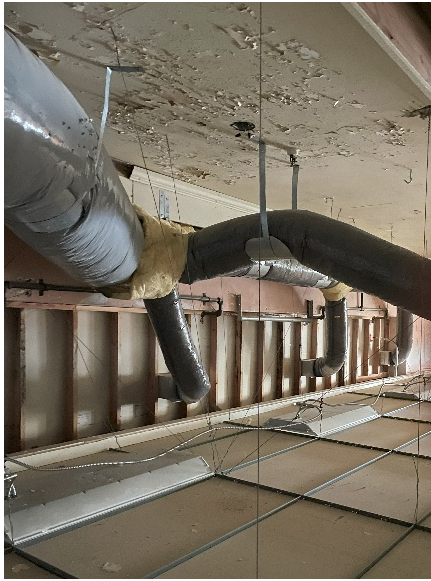
Majority of ducts are partially or fully uninsulated. Interiors of ducts were not inspected, however the exteriors showed damage, patched, disconnected and capped ducts throughout, all of which will require replacement to facilitate new system installation.

Figure 9. Ductwork above 213A, supplying 213

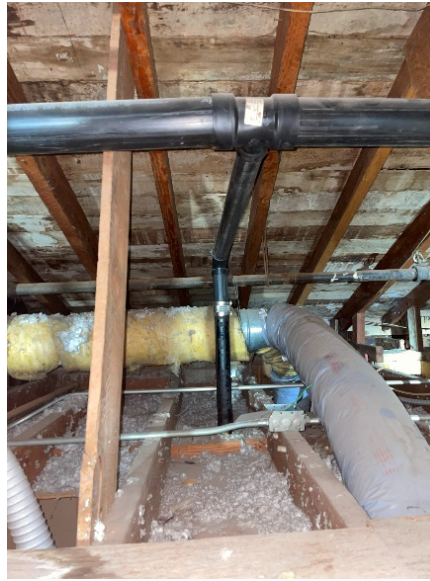
Figure 10. Ductwork condition in Attic Space

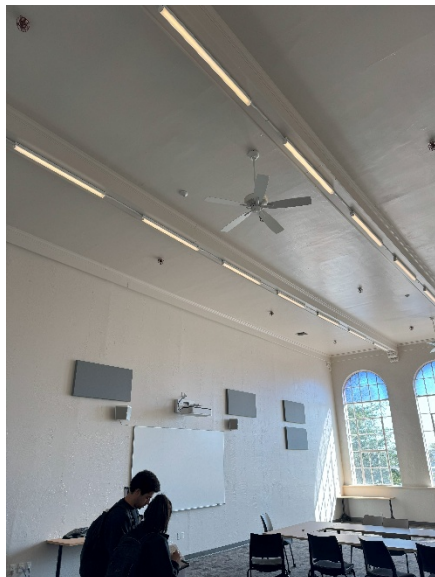
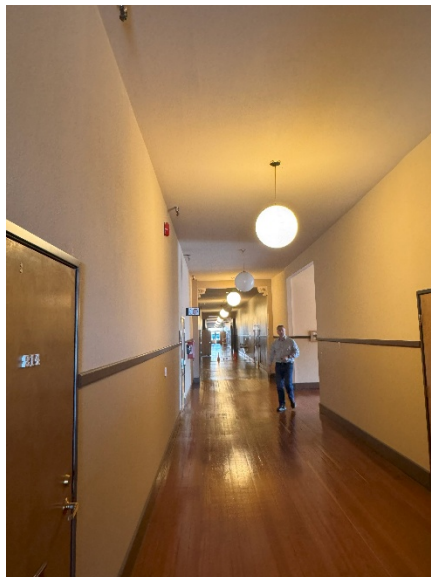
The existing interior lighting systems are comprised of various sources; fluorescent, CFL, LED, with many of the lamps having failed or the luminaires in general being in bad working condition. Some spaces like the main corridors have lighting solutions adequate and representative of the space and use case. There are some spaces where LED fixtures have been added but are not integrated or aligned with the use of the space or the architectural quality of the space.

Above: Examples of various interior lighting systems

All lighting and lighting controls will need to be replaced to meet code. Refer to Recommendations for general upgrade suggestions.

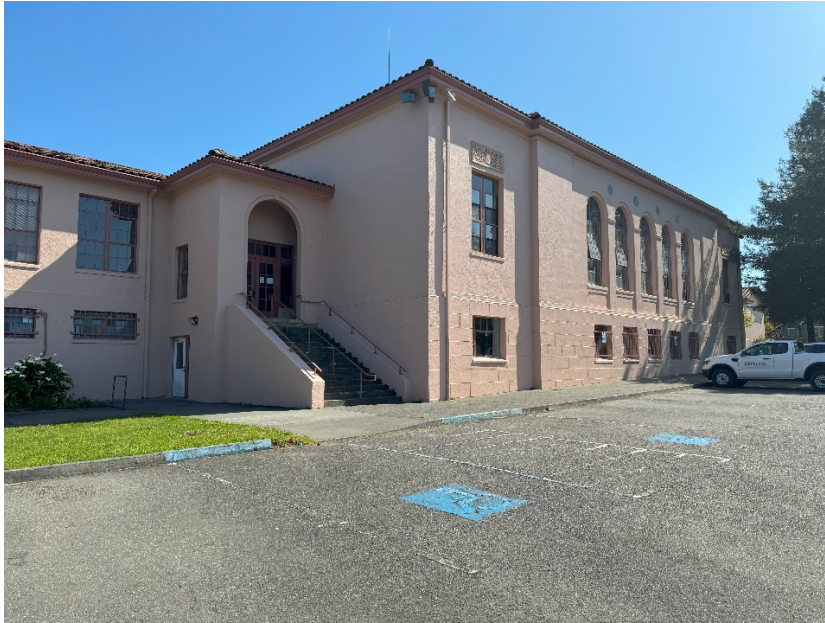
functional and others clearly not. Lighting for the site does not appear to be adequate for the use case due to lack of parking lot lighting and general lighting for pedestrian movement around the site. Additionally, there is concern about light trespass beyond the building property line due to nature of soffit lighting being high and aimed outward away from building. Although, no night time lighting assessment has been completed to date.

Above: Example of only types of exterior lighting, mounted high at roof soffit

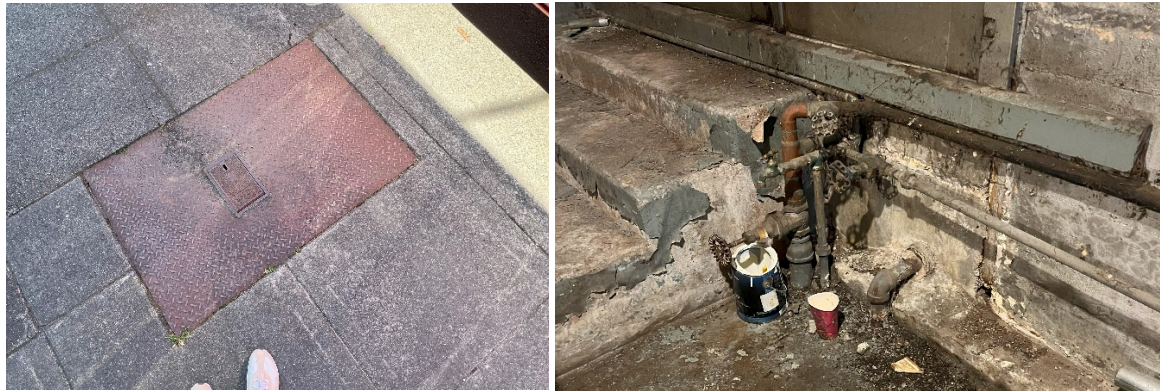
Cold water (1-1/2") enters the building from the North. There is a below-grade meter located within the sidewalk and shut-off valve in the building.

Above: Below-grade water meter and water service into building

Based on the planned program, the cold water service will need to be upsized with a new service.

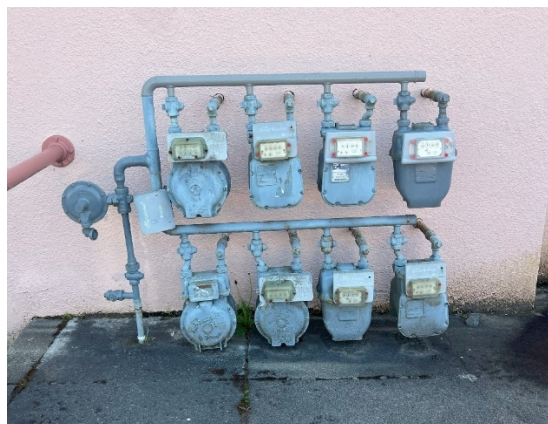
Gas enters the building from the North. There are multiple meters installed against building exterior, exposed at the sidewalk.

Above: Gas service and gas meters into building

Based on the planned program and Cal Poly Humboldt's goal for reduced carbon footprint, the natural gas service will be removed in its entirety.

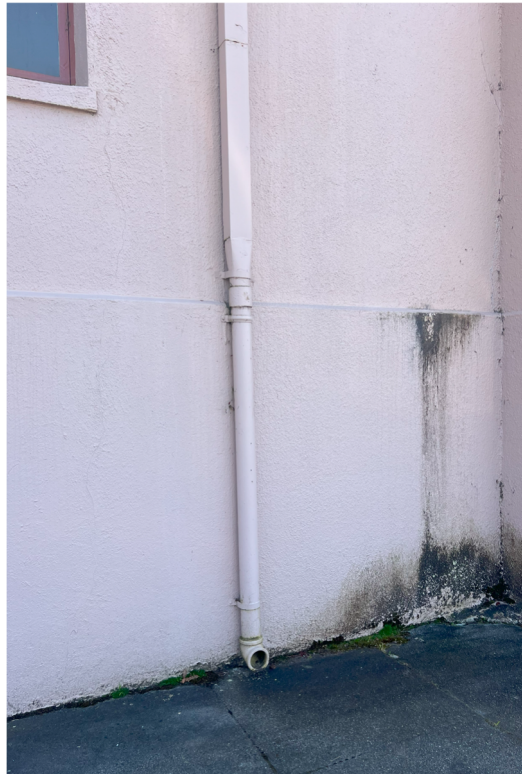
Storm drainage is conveyed down sloped roofs to gutters and exposed downspouts around the perimeter of the building. Some downspouts appear to discharge into landscape/grade and others continue to below grade. Additionally, the exposed downspouts at the pedestrian level have been damaged and in some instances replaced with steel piping. The project will consider replacement of the downspouts to be consistent when exposed to view.

Above: Storm drain leader to grade

- Discharge from downspouts shall be modified to not splash onto walkways. This can be achieved by routing underground and daylighting at curbs via thru-curb drains where possible or incorporating planters adjacent to the building.
- Additional landscaping elements beyond what may be required for bioretention purposes is not currently allocated within the scope of the project. The general intent is for existing landscaping and vegetation to be protected in place. Some existing landscaping and vegetation will more than likely need to be removed for recommended building systems, once selected, and for building envelope upgrades. Landscaping elements to be removed should be reviewed by the University and the Design Team for relocation or replacement landscape where required.

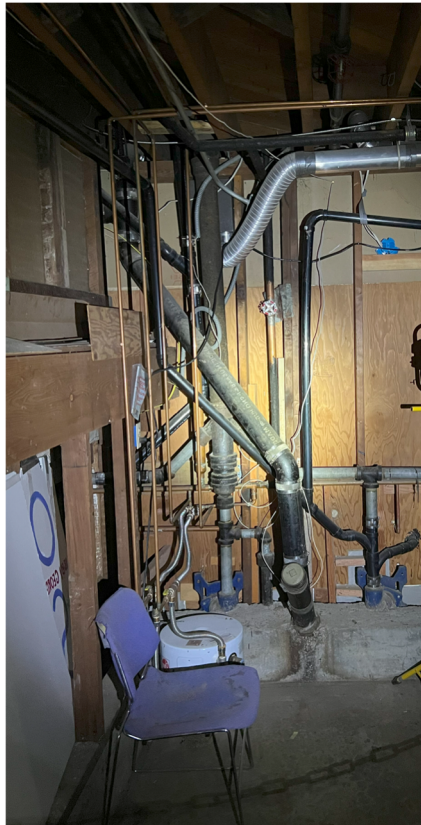
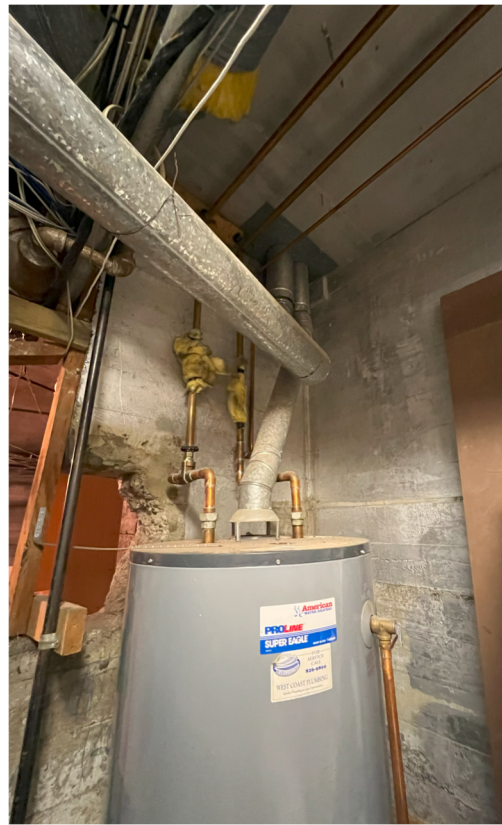
Hot water piping is not consistently insulated per code.

Above: Water heater with uninsulated domestic hot water piping

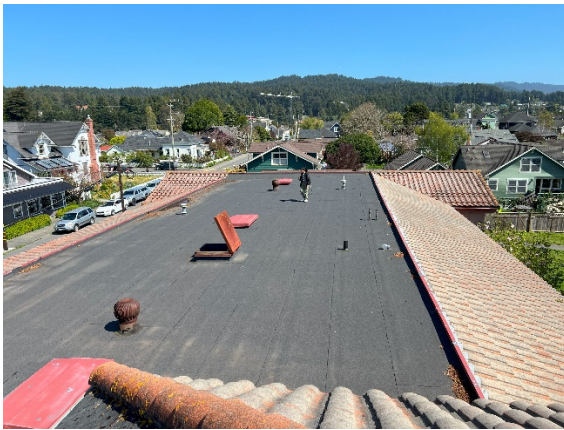
BUR: There is no obvious insulation at the BUR. Slopes on the low-sloped roofs are nearly flat and do not meet current low-sloped roofing standards. There is evidence of ponding on the roof. There are also numerous areas below the roof that attempt to catch water at intermittent leaks; no water was present at the time of site walk.

Figure 14 – BUR at Low-Sloped 'Low Roof'

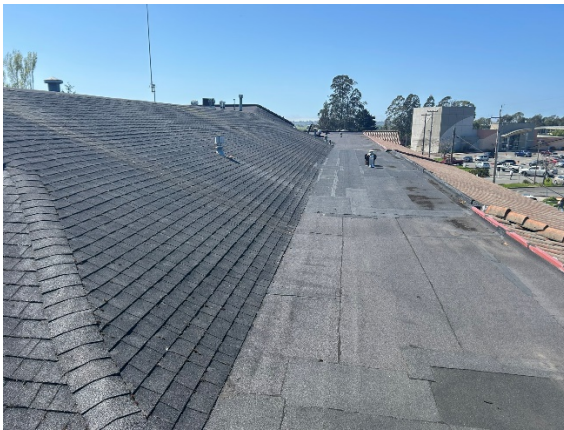
Figure 16 – BUR to Asphalt Shingle Roof Transition

The sides of the asphalt roof terminate under the barrel tiles that typically ride the ridge in a typical barrel-tile/S-tile roof.

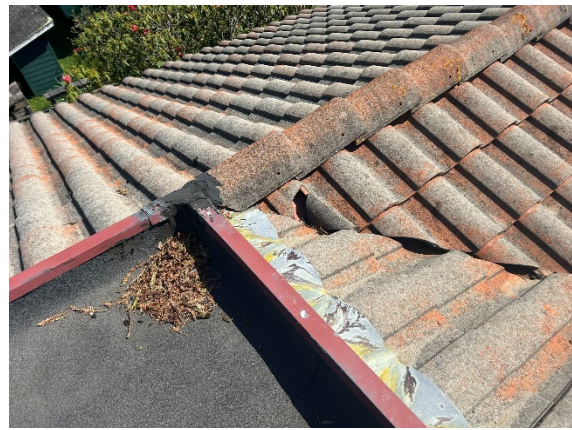
Concrete S-tile roof: The perimeter of the roof has concrete S-tiles which appear to be quite old. A number of tiles are broken at various locations. There is lead flashing visible at many of the roof intersections as well as at the top row of tiles from the flashing cap.

Figure 17 – Concrete S-Tile Roof

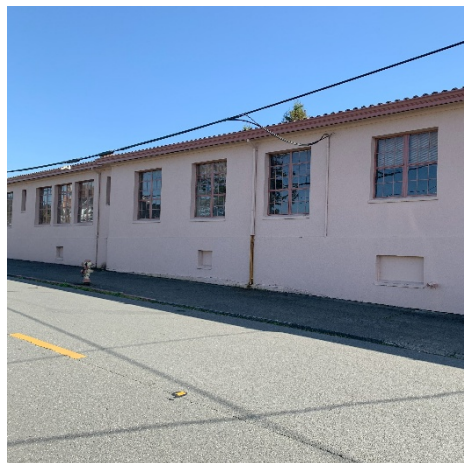
Fire Water: The existing building is sprinklered with a wall-mounted FDC on the northern building wall near the electrical room entrance. The firewater backflow device/check valve with pressure gauge occurs at the building interior side of the exterior wall-mounted FDC. The service lateral size and location are not currently known and further information from the topographic survey, as-built drawings and block maps from the utility provider are needed. Fire water piping and device improvements may be needed.

Above – 16th Street Fire Hydrant and FDC

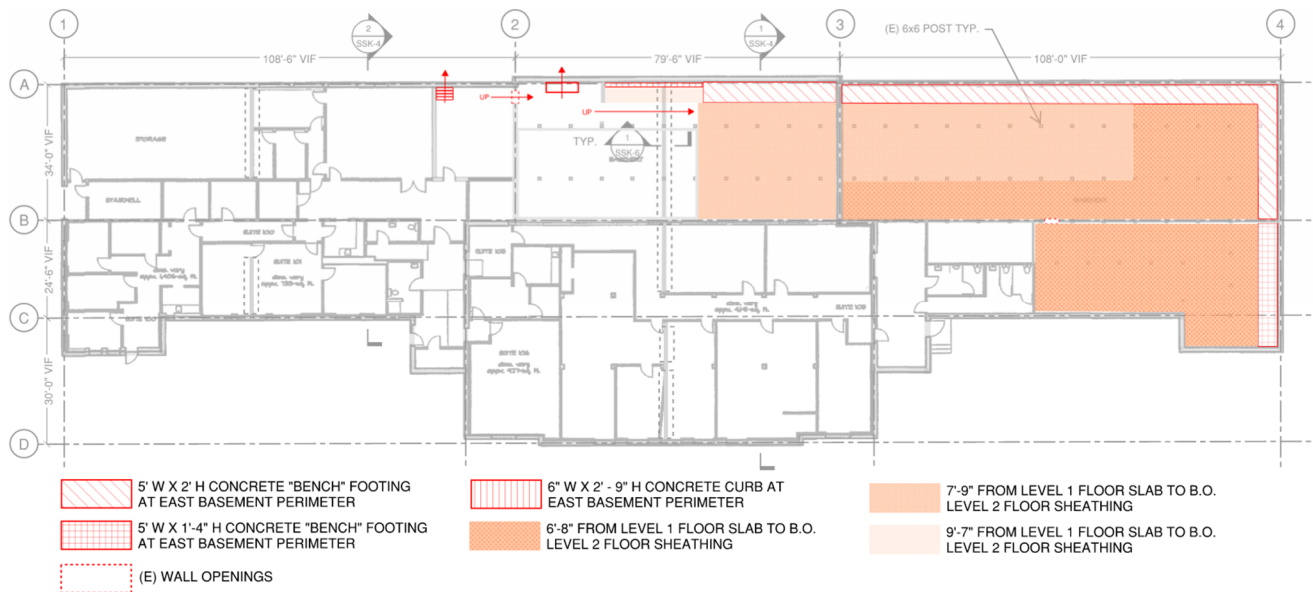
Level 1 Grade: As previously noted, Level 1 has a slope running west to east with the eastern half of Level 1 retaining soil, as identified in the *Independent Structural Review and Concept Retrofit Report*. The non-accessible service and back-of-house portion of Level 1 within the eastern wing, poses notable areas of concern relative to overall top of slab to bottom of structure elevations and the presence of a 5'-0" wide by 2'-0" tall concrete "bench" footing along the building perimeter (see Figure 18 and Appendix 8). At its tightest condition, the bottom of beam is at 6'-0" and generally holds a 7'-0" and 7'-9" to bottom of beam and structural floor sheathing elevation respectively. The area would require structural modifications to the building foundations, bearing walls, columns and beams to increase the head height of the space to code compliance in order to be utilized as occupiable building space for the Health Hub program.

Figure 18 - Stewart Building Level 1 Floor Plan: Floor Slab to Bottom of Structure Elevations at Non-Occupiable East Wing

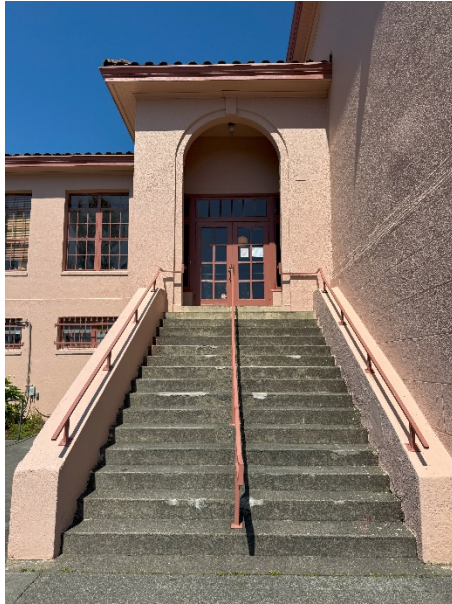
South Elevation Entry Stairs: As previously noted, the south Level 2 entry-points consist of two separate entries at the top of the two stairs that are not compliant with accessibility requirements. These stairs and the associated entries will need a detailed survey for accessibility compliance to determine if selective demolition of a portion or all the entry, to include stairs, is required to generate a code compliant entry access point. See Architectural and Accessibility Recommendations section for more information.

Figure 19 - Southwest Entry Stairs

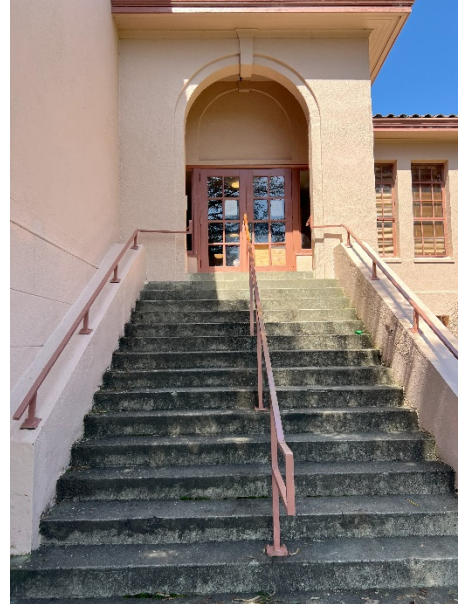
Figure 20 - Southeast Entry Stairs

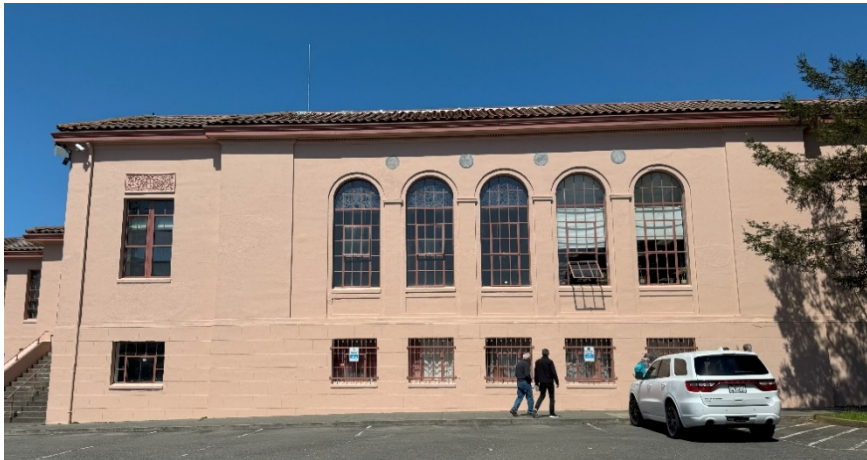
South Elevation Arched Window Openings: The large arched openings at the south elevation are a substantial architectural feature of the building exterior that will need to remain. While the replacement of the windows within the openings is recommended, an in-kind replacement will be required so as not to cause any historical jurisdictional concerns.

Figure 21- South Elevation Arched Window Openings

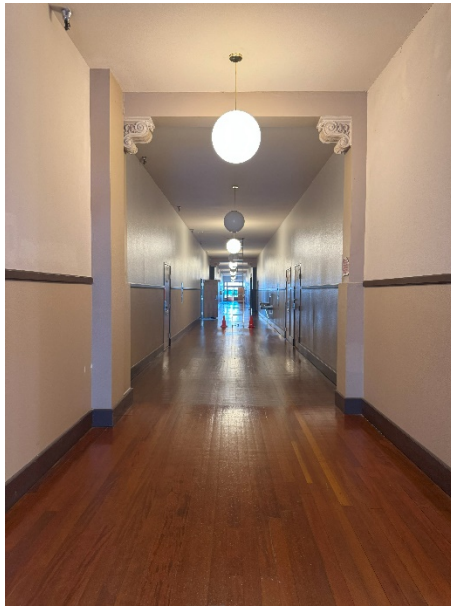
Original Hardwood Floors: The main Level 2 hallway appears to have original hardwood floors. Similarly, the original hardwood floors, exposed in suite 211 have apparent adhesive residue from a previous underlayment for a carpet or vinyl floor. It is assumed that hardwood floors are beneath all carpeted and vinyl flooring at Level 2. From the limited portion that could be observed, the condition of the floors varies. Per the *Healthcare Hub Schematic Design Basis of Design Document* dated March 4, 2025, the design intent is to repair, refurbish and maintain the existing wood floors at the Level 2 common hallway. It is our understanding that all the interior walls and rooms will be part of a separate demolition package, and the demolishing of hardwood floors would need to be reviewed and confirmed with the University and be vetted against structural design and HVAC solutions for the building.

Figure 23 - Main Hallway Hardwood Floors

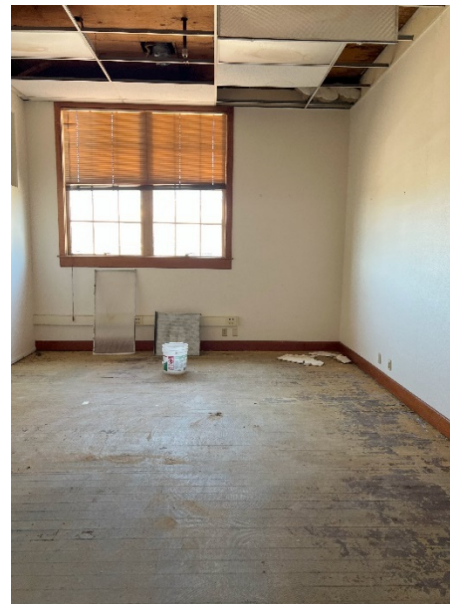
Figure 24 - Suite 211 Hardwood Floors
