Technical Memorandum

Cal Poly Humboldt Parking Lot G11 – Asbestos and Lead Survey Data Summary **XPL344 – Parking Lot G11 Accessibility Improvements Project**

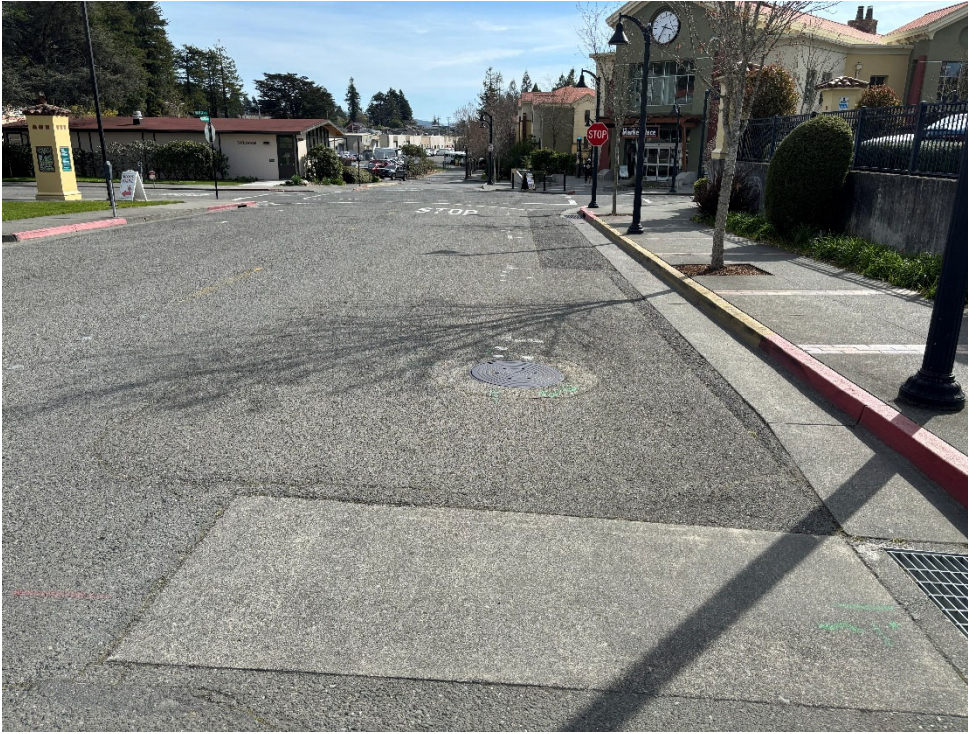
Photograph 1 – Rossow Street – red paint (typical) contains lead – view looking south

As noted in Table 2, two (2) samples both representing paint on concrete curbs were reported to contain lead. Paint on concrete curbs shall be presumed to contain lead throughout. Typical examples of the lead material identified onsite are shown in the attached photographs (Attachment A). The locations of lead samples collected onsite are shown on Figure 1 (Attachment B). The AAS laboratory analytical reports for this survey are attached (Attachment C).

Based on the data collected onsite, lead is known to be present at the project site. Painted coatings and shall be presumed to be LBP unless sampled and proven otherwise. Construction work impacting any amount of lead, including known or presumed LBP and/or LCP, must comply with applicable Cal/OSHA regulations (8CCR1532.1). Work impacting LCP or LBP shall additionally comply with CDPH lead safe work practices (17CCR§35001).

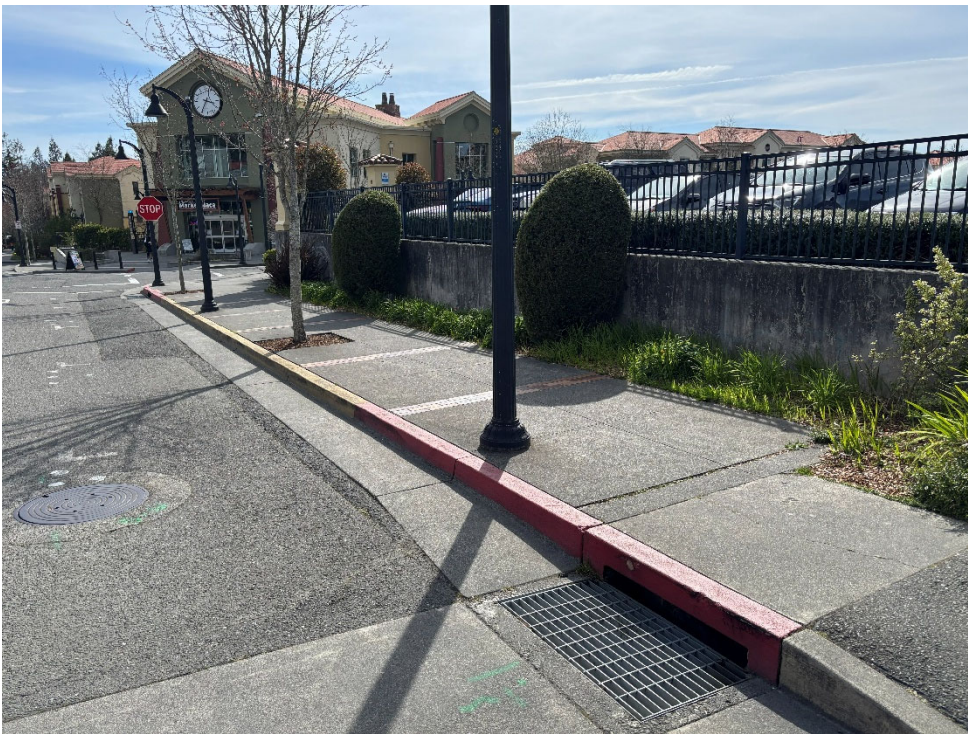
Photograph 2 – Parking Lot G11 retaining wall and Rossow Street sidewalk – red paint (typical) contains lead – view looking southwest

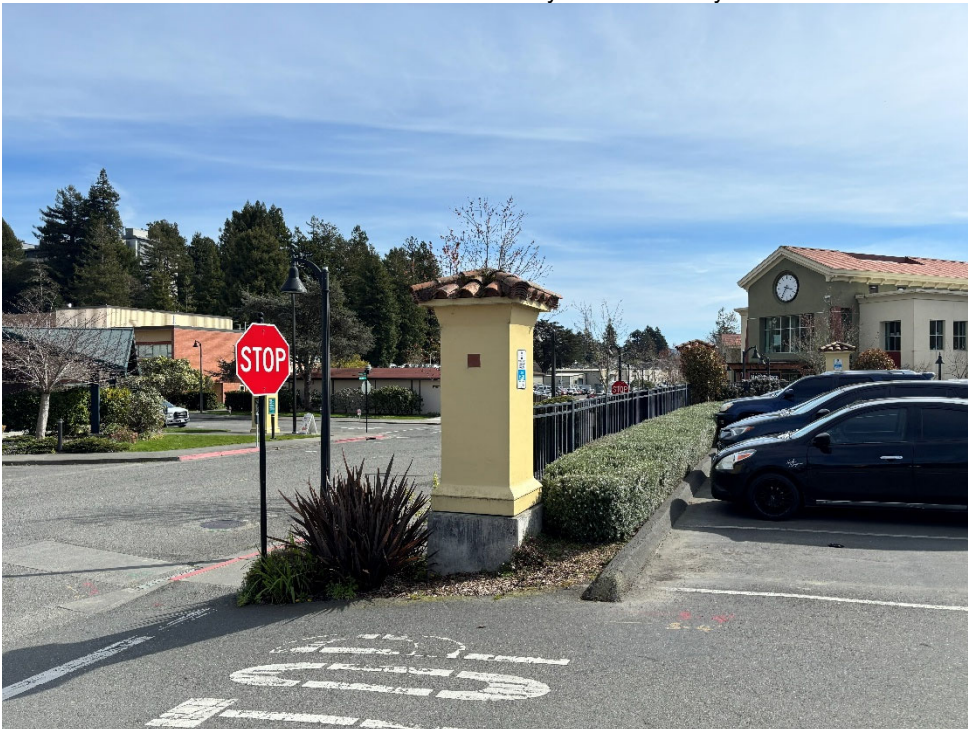
Photograph 3 – Parking Lot G11 retaining wall column and south lot exit – red paint (typical) contains lead – view looking south

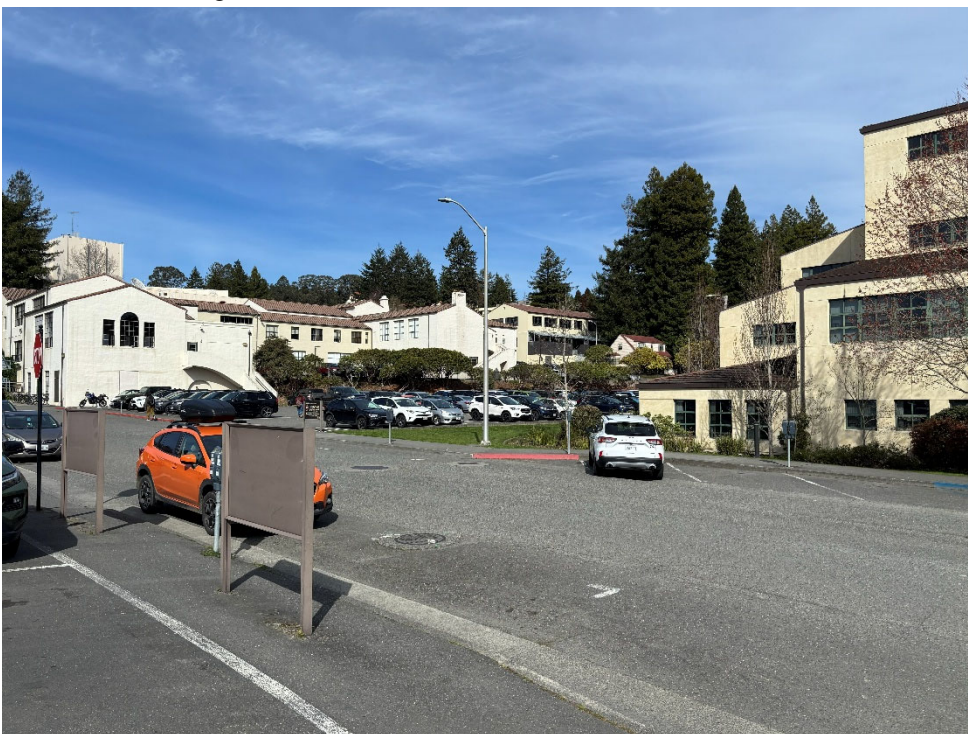
Photograph 4 – Parking Lot G11 east terminus and Rossow Street – red paint (typical) contains lead – view looking northeast

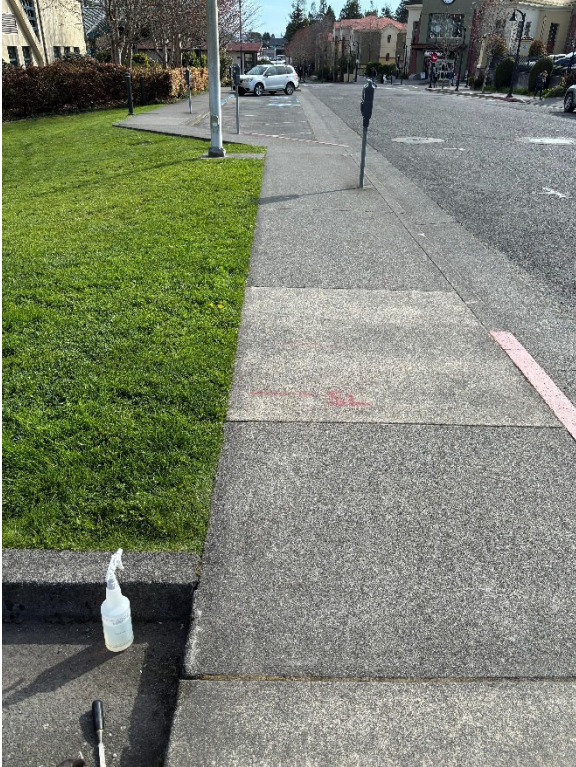
Photograph 5 – Rossow Street east sidewalk – red paint (typical) contains lead – view looking south

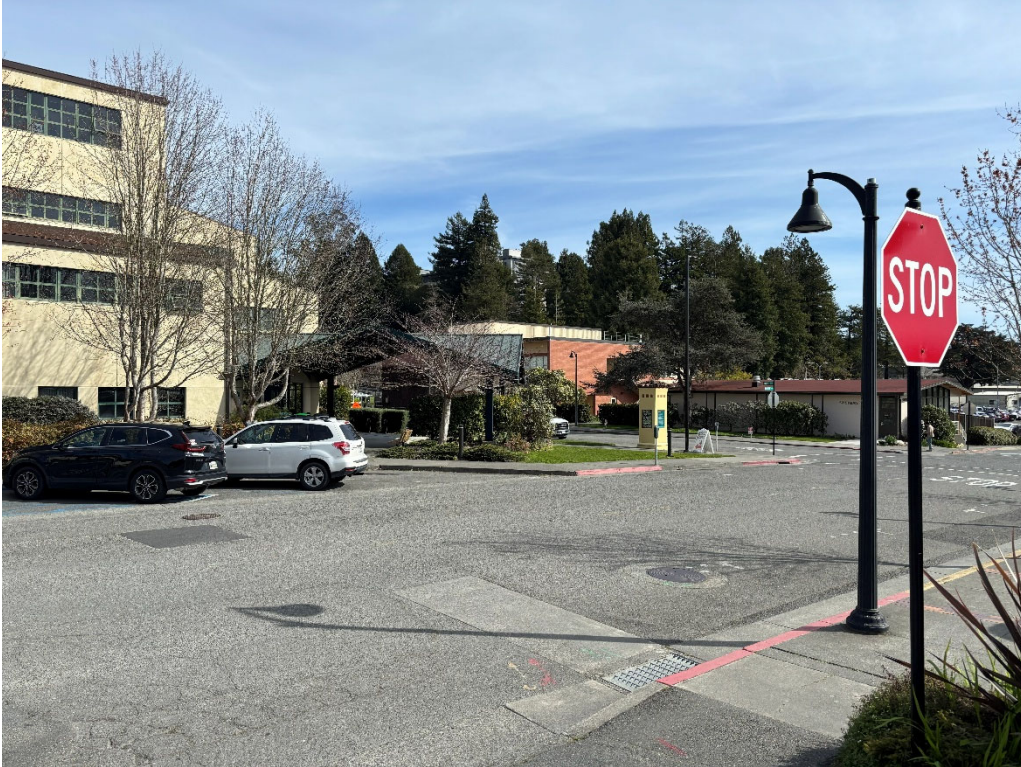
Photograph 7 – Rossow Street and SBS flatwork – red paint (typical) contains lead – view looking southeast
