Independent Seismic Review and Concept Retrofit Design

Stewart Building 1125 16th Street Arcata, CA

Performed for Compliance with CSU
Seismic Requirements

Maryann T. Phipps
Megan E. Doxzen
Benjamin Biddick
January 31, 2025

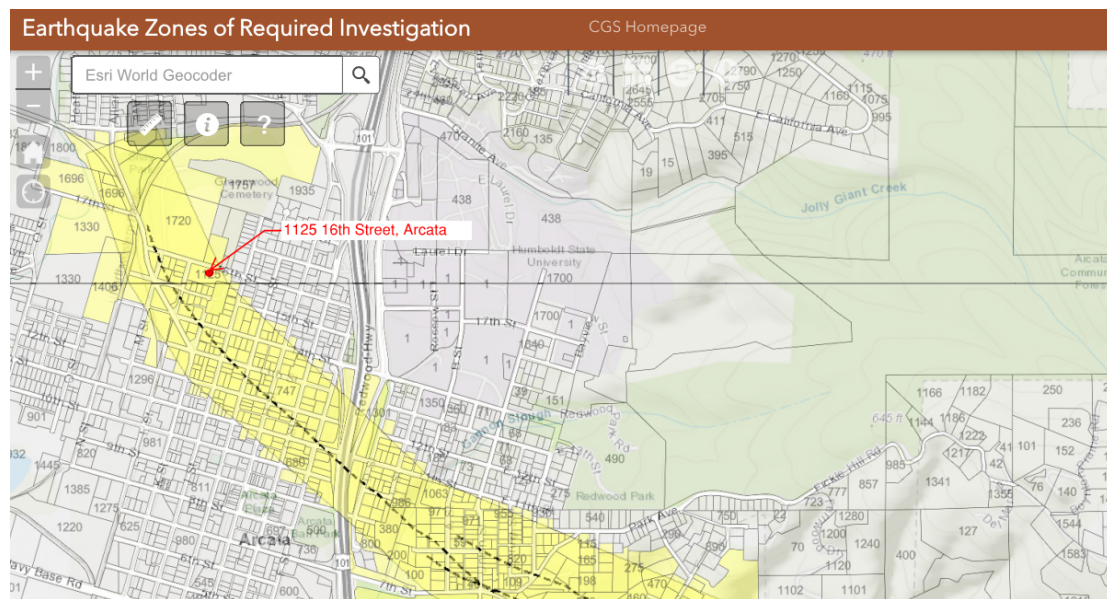
Figure 1 – Earthquake Fault Zone from CGS

The two-story structure was dedicated in 1925 as the Stewart School and is located approximately 330 feet from the nearest known fault. According to published maps made available by the California Geological Survey (CGS), the building lies within the mapped Earthquake Fault Zone (Figure 1). According to the CSU Seismic Requirements:

All planned construction within the Earthquake Fault Zone shall have detailed geologic studies of the building site to determine if a fault trace passes through, or is within 50 feet, of the building perimeter.

In order to determine whether future development at this location would be permitted, a report entitled “Fault Study Hazard Evaluation, Fine Arts Facility, Arcata High School” conducted for an adjacent parcel on behalf of the Northern Humboldt Union High School District (by SHN Consulting Engineers & Geologists, September 2012) was reviewed by CSU Seismic Review Board member and Geotechnical Engineer John Egan. John determined that the results of that evaluation (i.e., the trenching and interpretations) are sound and can be extrapolated south along the mapped Fickle Hill fault trace to indicate that the Stewart Building site has sufficiently low risk of surface fault rupture to permit future renovation and occupancy by CSU.

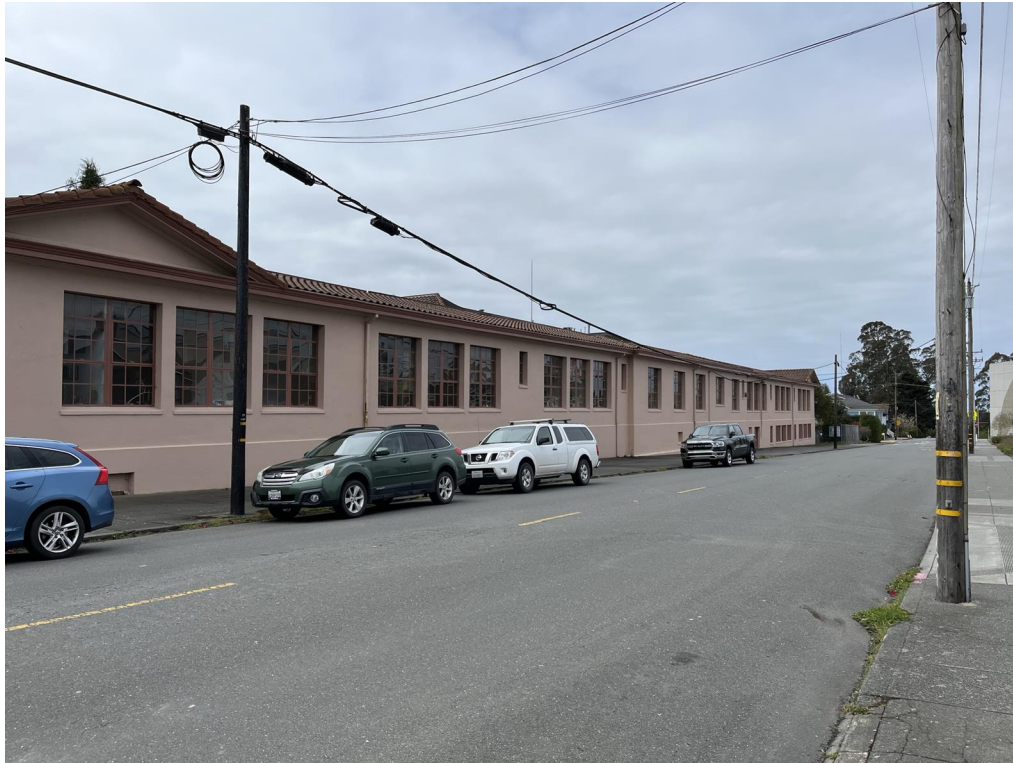
Figure 2 – North side of 1125 16th Street, which slopes down to the west

The building is built into a shallow hillside such that the ground floor walls at the east end retain approximately 5 feet of soil. The east-west slope along 16th Street is approximately 3% (Figure 2). As of the date of this report, the property has not been

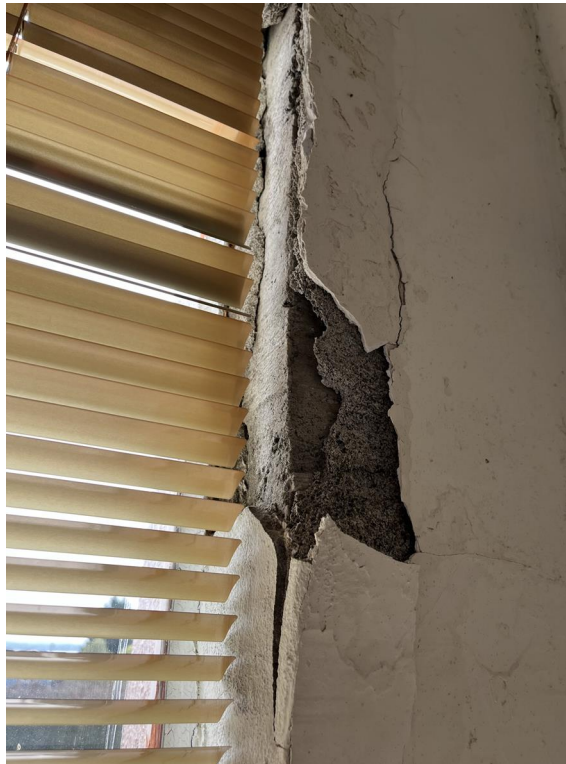
The lateral force-resisting system consists of reinforced concrete shear walls in both the north-south and east-west directions. The walls are 8" thick at the second floor and approximately 12" thick at the first floor. One layer of vertical 3/8" square reinforcing bars spaced at roughly 24" on center were observed extending up from the top of the wall at one location. The window and door openings typically align between floors. The concrete walls are finished with 1" thick plaster (Figure 7). There is a full-height, straight-sheathed wood wall at the north side of the high roof that may also carry some lateral load.

Figure 7 – Perimeter concrete wall at second floor with plaster finish.

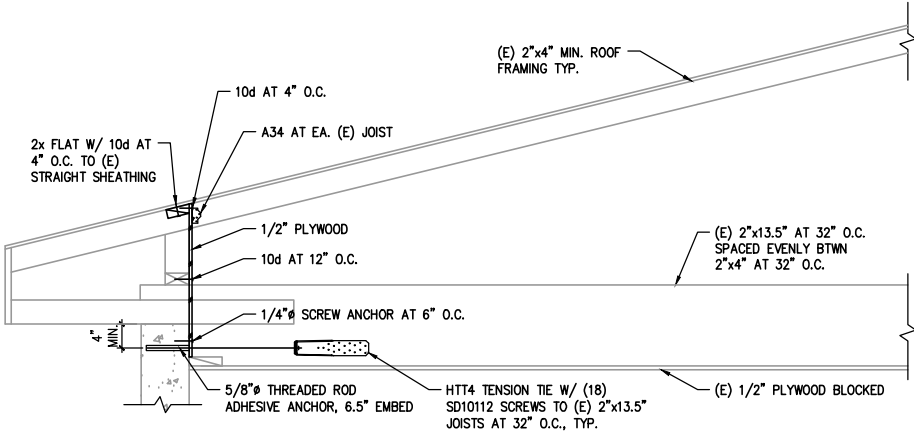
14 OOP WALL ANCHOR AT ATTIC LONGITUDINAL WALLS AND IN-PLANE SHEAR TRANSFER FROM ROOF TO EXTERIOR WALLS
NOT TO SCALE

- Out-of-plane wall anchorage at flexible diaphragms: The observed anchorage at the attic and second floor diaphragms is insufficient to reliably brace the concrete walls out-of-plane.

- Transfer of in-plane loads from flexible diaphragms to shear walls: At the sloped high roof, the cripple walls cannot adequately transfer shear to the concrete walls. At the main roof, the 1'-2" gap between the diaphragm and the top of the concrete walls indicates there is no load path to deliver in-plane shear to the concrete walls.

- Out-of-plane wall anchorage at flexible diaphragms: Additional concrete anchors will be installed to brace the concrete walls to the attic and second floor diaphragms.
- Transfer of in-plane loads from flexible diaphragms to shear walls: At the high roof, plywood sheathing will be installed on the cripple walls below the high roof. At the main roof, the 1'-2" gap will be filled with plywood blocking fastened to the straight sheathing above and the concrete wall below.
- Wood diaphragm spans: New plywood shear walls will be installed at the first floor in the north-south direction to reduce the second floor diaphragm spans.
- Continuous cross ties between diaphragm chords: Tension ties will be installed at joist splices at the attic and second floor diaphragms.
- Falling hazards: Tie wires will be installed through each clay tile and fastened to the roof sheathing.

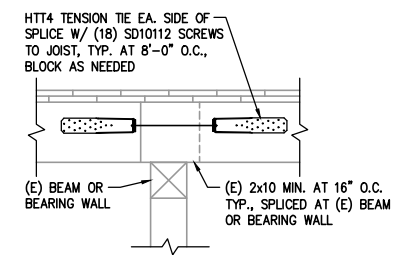
8 CROSS-TIE AT JOIST SPLICE
NOT TO SCALE

- Continuous cross ties between diaphragm chords: Continuous cross ties were not found at joist splices.
- Falling hazards: The clay tiles are not positively attached to the roof sheathing.
