**CALIFORNIA POLYTECHNIC UNIVERSITY,
HUMBOLDT**

HEALTHCARE HUB

STEWART BUILDING ASSESSMENT

June 5, 2025

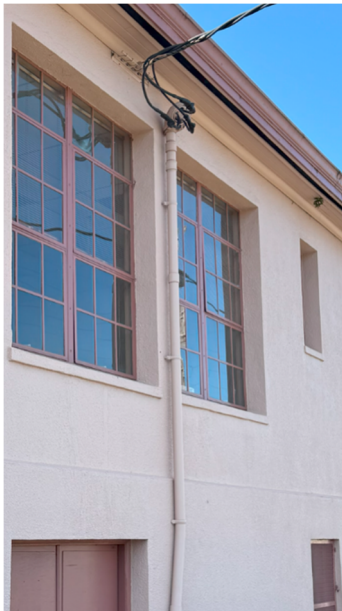
Figure 11. Overhead Service

The existing electrical service is supplied by Pacific Gas and Electric (PG&E). Power is delivered via an overhead connection originating from a pole-mounted utility transformer located on 16th Street. The service conductors are routed through a weatherhead to the Level 1 service equipment (see Figure 11). The existing service is rated at 600A, 120/240V, 1-phase, 3-wire and is equipped with six (6) utility meters (see Figure 12). This single-phase system lacks the capacity and flexibility required for a healthcare hub, which demands higher power density and support for higher-voltage loads. As such, a complete replacement of the electrical system – including electric service equipment, distribution equipment, feeders, and devices – is necessary to meet program requirements. Refer to the Recommendations section of this narrative for detailed upgrade options and implementation guidance.

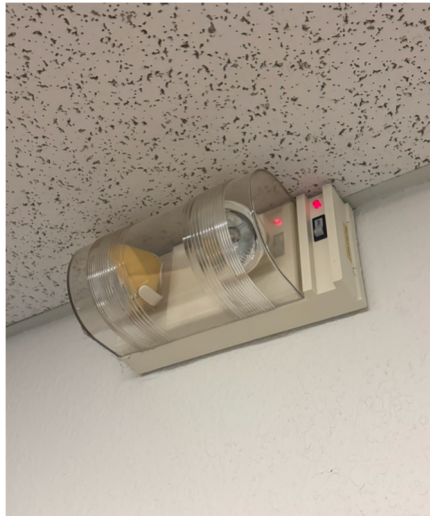
Figure 13. Emergency Lighting Unit

There is currently no emergency generator or central inverter system on site. Emergency power available is limited to battery-powered emergency lighting units, commonly referred to as “bug-eye” fixtures, installed to illuminate egress paths upon loss of normal power (see Figure 13). The fixtures are sparsely distributed throughout the facility. A detailed assessment may be warranted to determine whether the current quantity and placement of units meet applicable life safety code requirements.

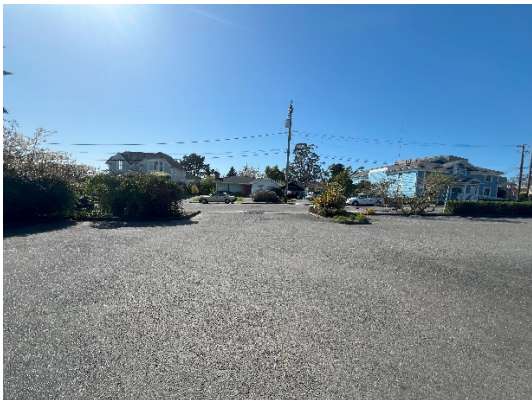
Above – L Street Vehicular Access Point

The existing exterior pavement at the driveway of the parking lot, the ADA parking spaces, and the access on the east side of the building are in moderately poor to poor conditions. The remainder of the asphalt appears to be in good condition.

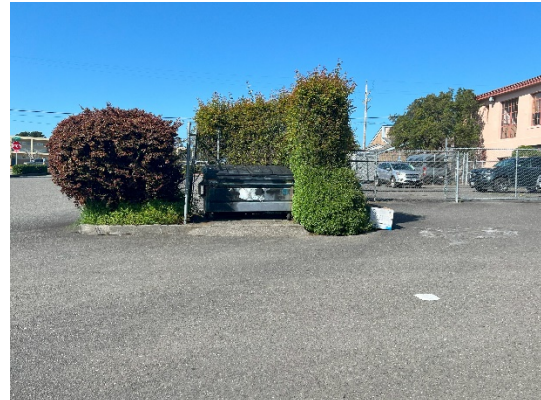
Above - Curb Island Adjacent to Fenced Fleet Parking

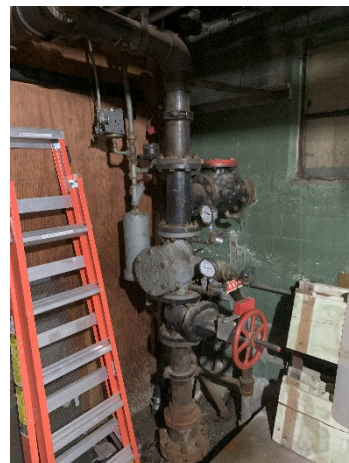
Above – Firewater Backflow Assembly

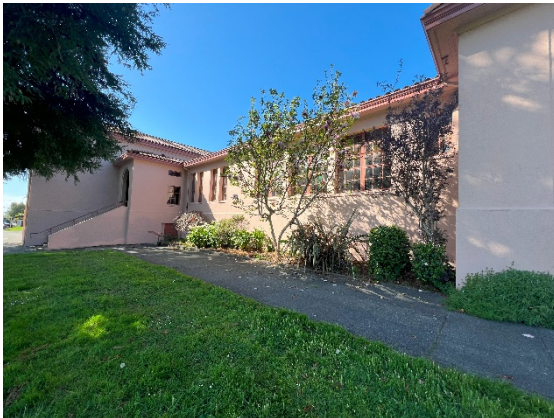
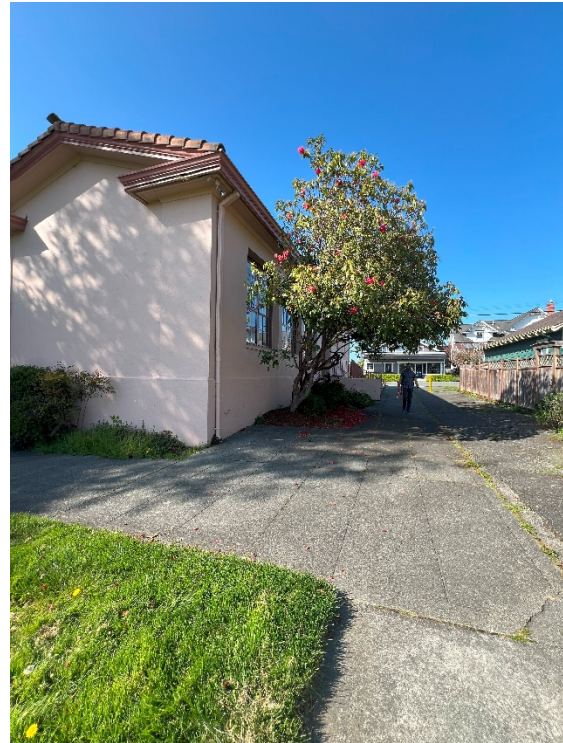
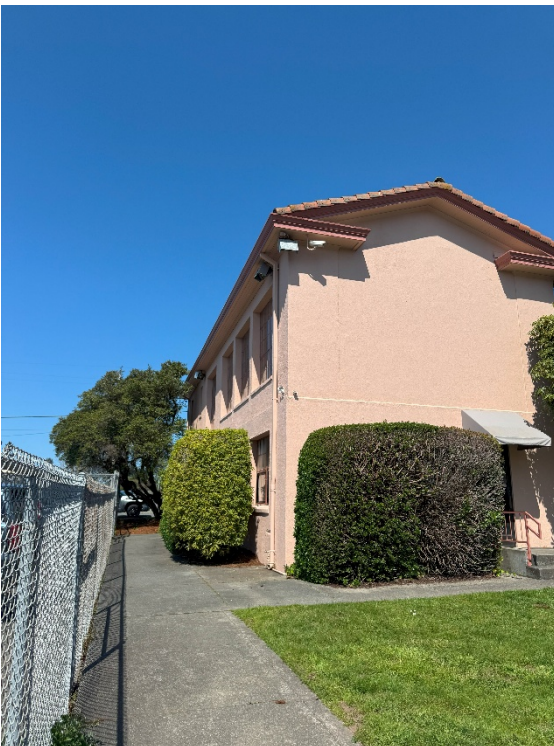
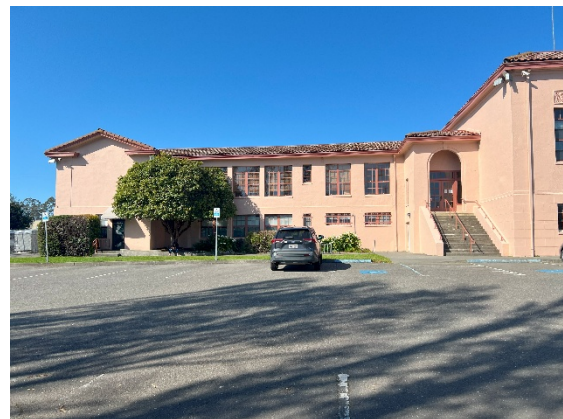
Above: General vegetation and landscaping around the building

- Discharge from downspouts shall be modified to not splash onto walkways. This can be achieved by routing underground and daylighting at curbs via thru-curb drains where possible or incorporating planters adjacent to the building.
- Additional landscaping elements beyond what may be required for bioretention purposes is not currently allocated within the scope of the project. The general intent is for existing landscaping and vegetation to be protected in place. Some existing landscaping and vegetation will more than likely need to be removed for recommended building systems, once selected, and for building envelope upgrades. Landscaping elements to be removed should be reviewed by the University and the Design Team for relocation or replacement landscape where required.

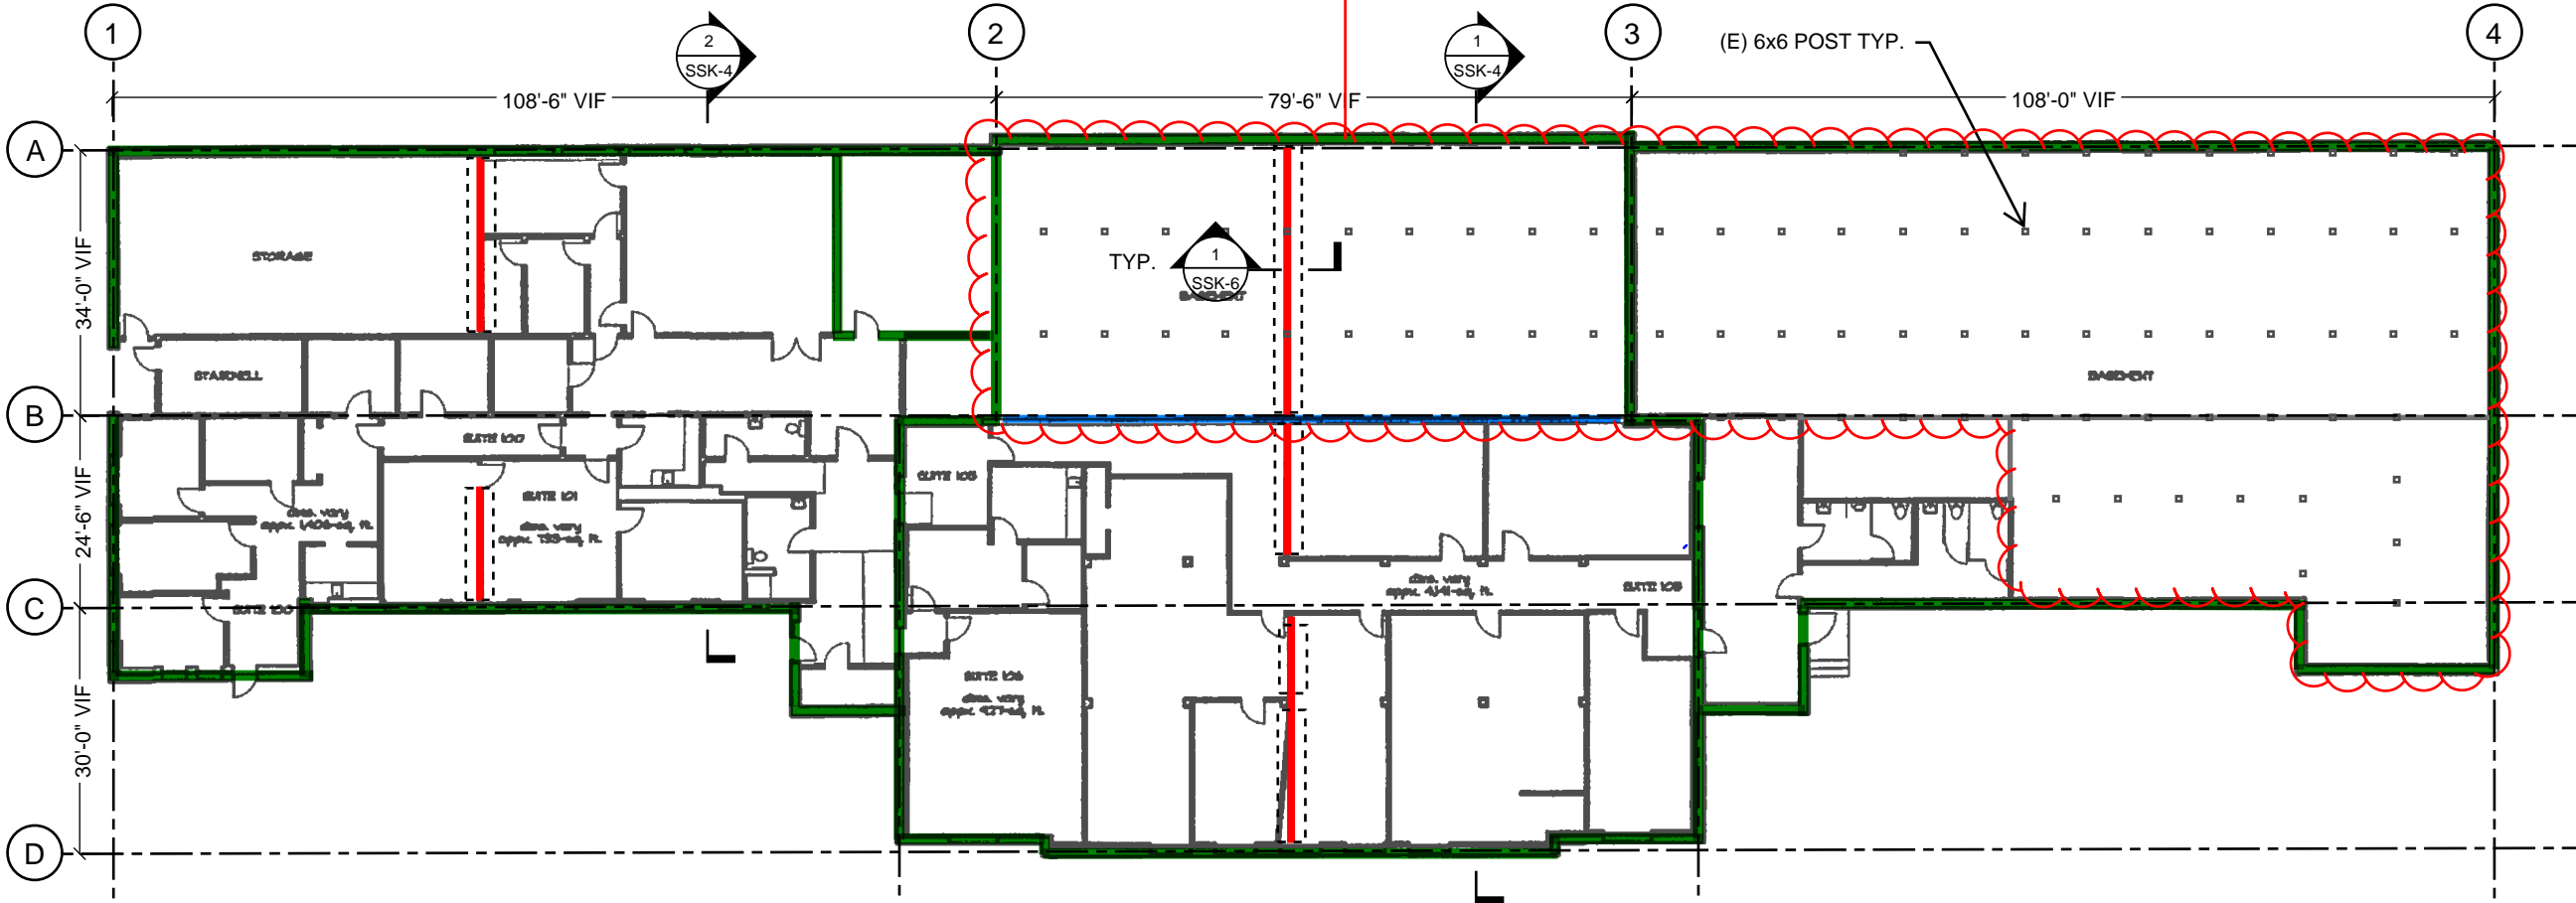
- SHEET NOTES:
- (E) CONCRETE SHEAR WALL WITH OPENINGS
 - (E) WOOD SHEAR WALL WITH STRAIGHT SHEATHING AND OPENINGS
 - (N) PLYWOOD SHEAR WALLS UP TO UNDERSIDE OF SECOND FLOOR ONLY
 - (N) STRIP FOOTINGS UNDER (N) PLYWOOD SHEAR WALLS
 - (E) FOOTINGS NOT SHOWN

1.0) Clear out stored materials and create a digital scan of space for design and construction team

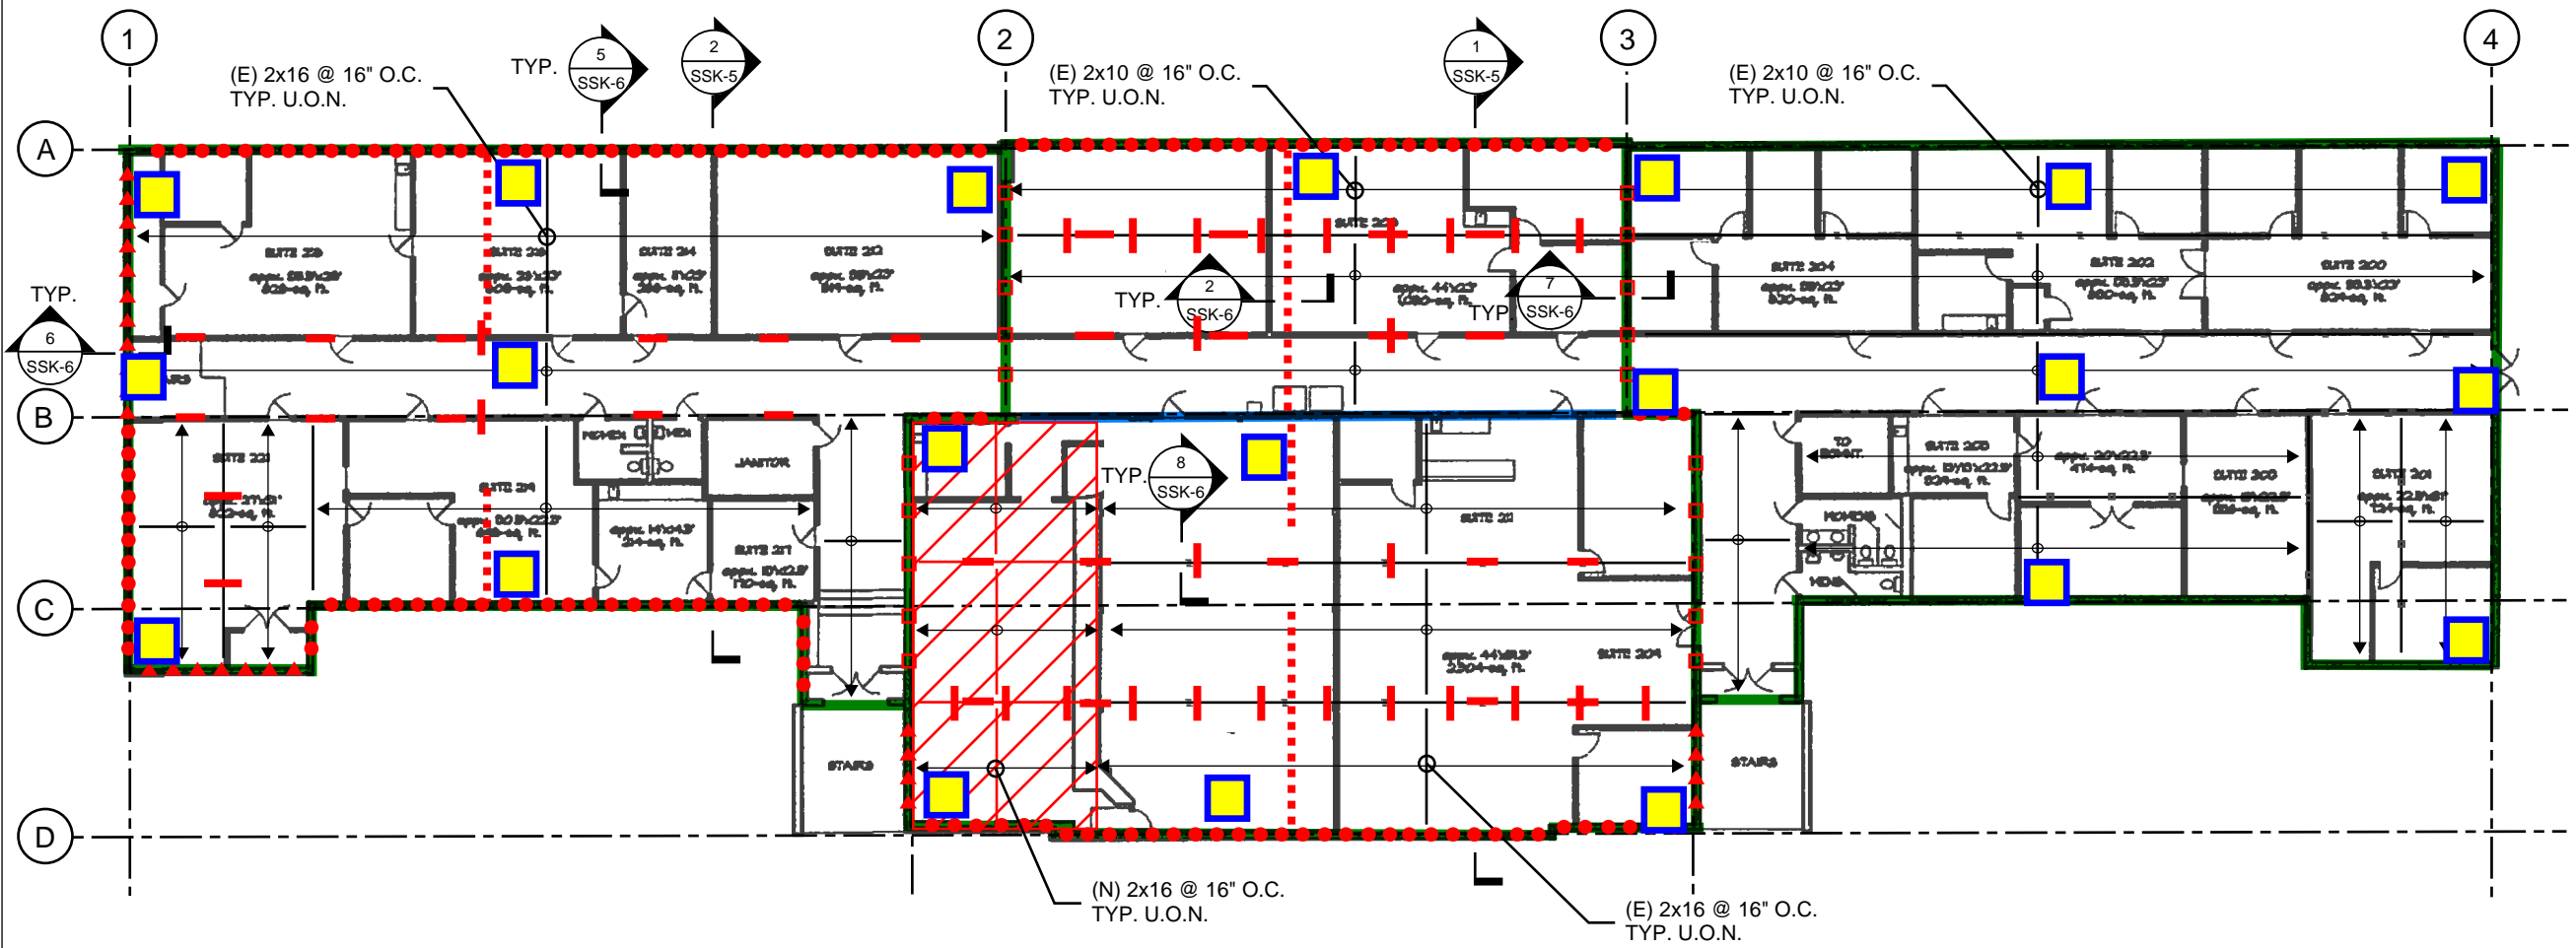
- (E) CONCRETE SHEAR WALL WITH OPENINGS
- (E) WOOD SHEAR WALL WITH STRAIGHT SHEATHING AND OPENINGS
- (N) WOOD SHEAR WALL BELOW
- OUT-OF-PLANE WALL TIE AT 32" O.C. (EVERY OTHER JOIST), TYPICAL AT CONCRETE WALLS WEST OF GRIDLINE 3 WHERE JOISTS ARE PERPENDICULAR
- OUT-OF-PLANE WALL TIE AT 36" O.C., TYPICAL AT CONCRETE WALLS WEST OF GRIDLINES 3 WHERE JOISTS ARE PARALLEL
- OUT-OF-PLANE WALLS TIES AT 5'-0" O.C. TYPICAL AT INTERIOR CONCRETE WALLS WHERE JOISTS ARE PARALLEL
- CROSS-TIES IN N-S DIRECTION AT SPLICED JOISTS AT 8'-0" O.C. TYPICAL AS SHOWN ABOVE (E) WOOD BEARING WALLS OR BEAMS
- CROSS-TIES IN E-W DIRECTION AT LOCATIONS OF SPLICED TOP PLATES OR BEAMS AT THE (E) WOOD BEARING WALLS
- DEMOLISH AND RE-BUILD RAISED FLOOR AT TYPICAL SECOND FLOOR ELEVATION

Indicates location to
remove ceiling to provide
clear view of structure for
inspection and
measurement

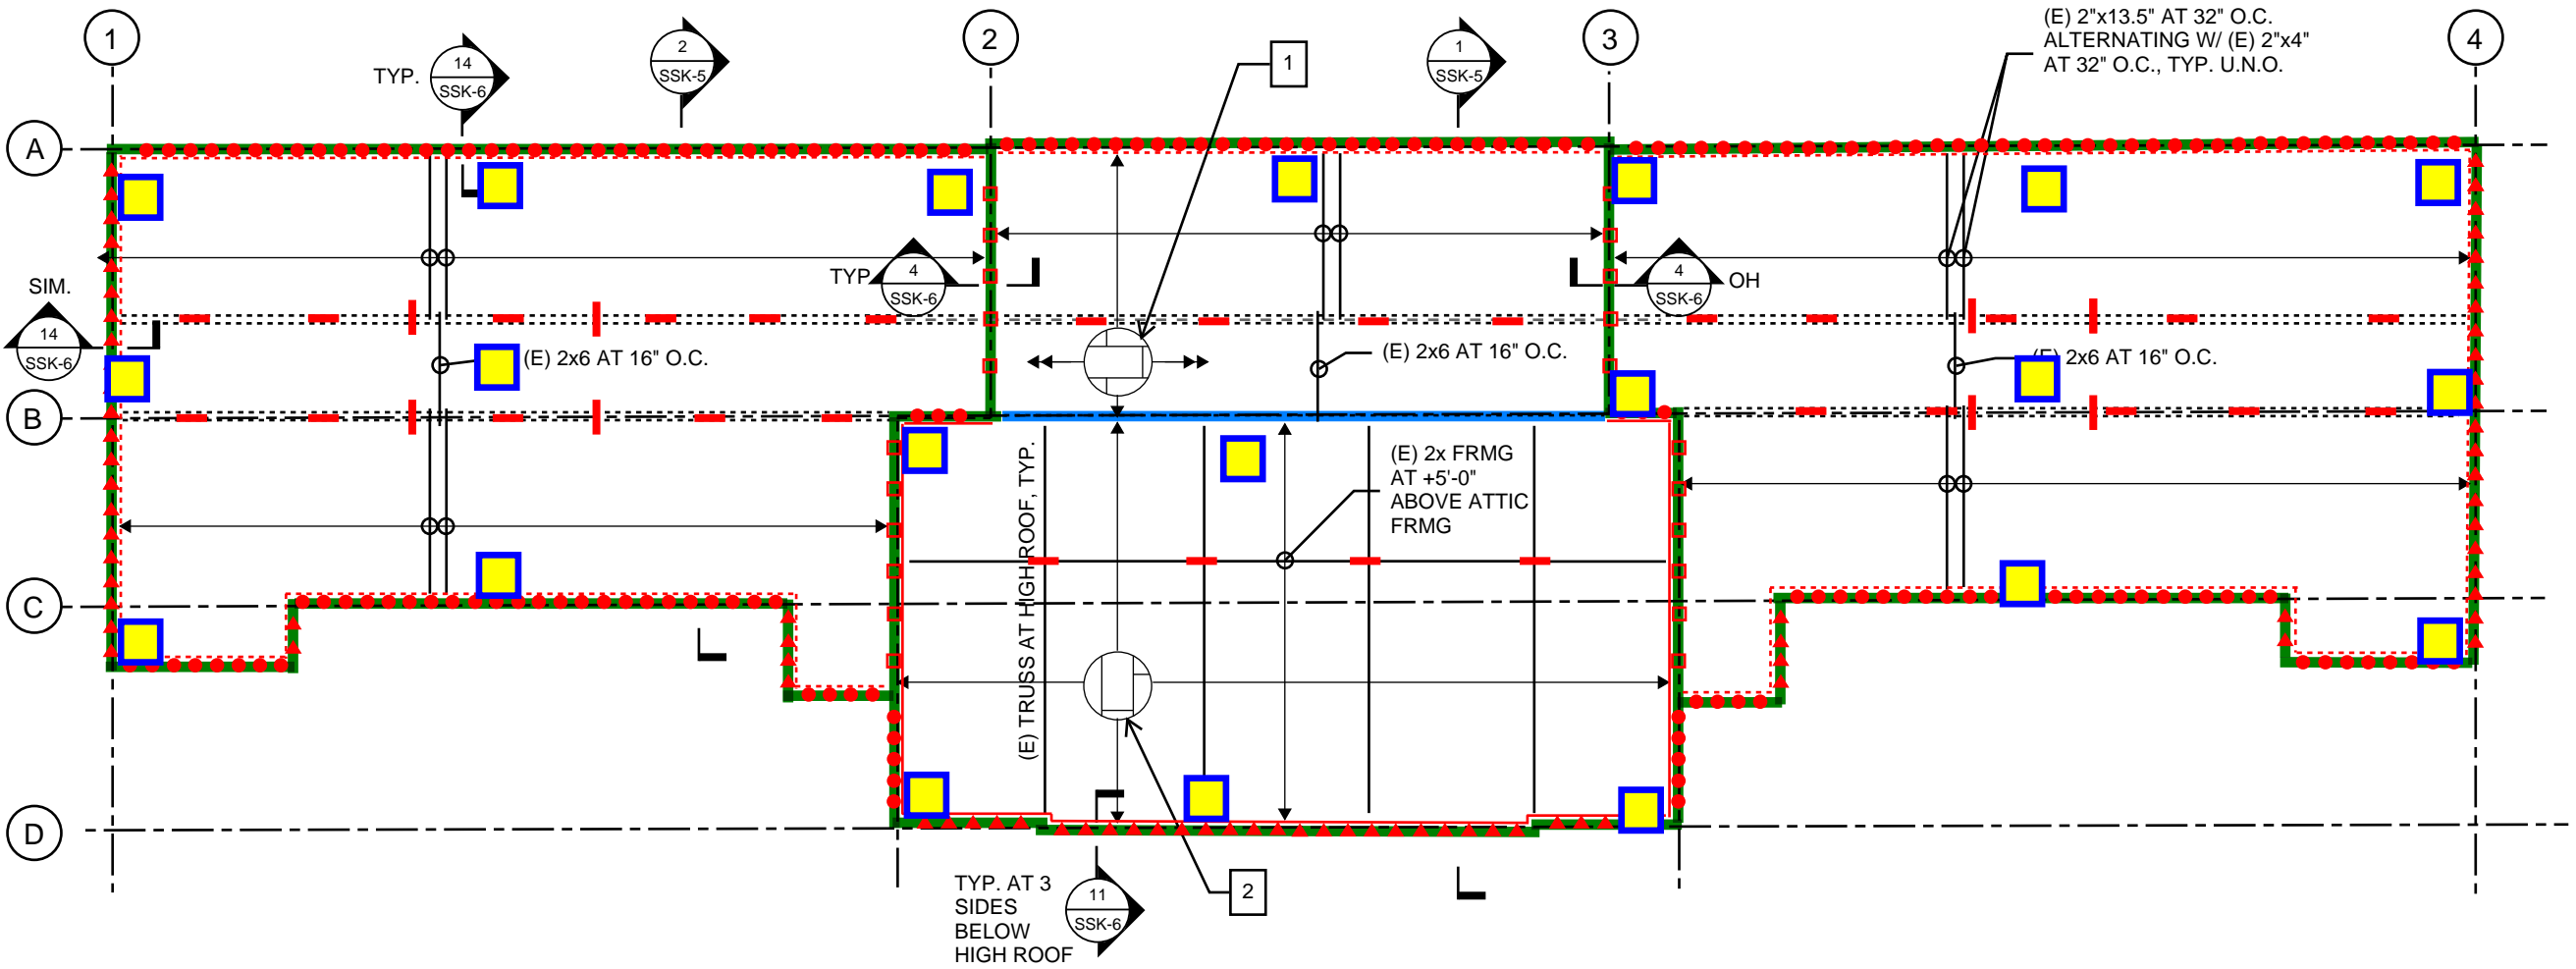
- CROSS-TIES IN N-S DIRECTION AT SPLICED JOISTS AT 8'-0" O.C. TYPICAL ABOVE (E) WOOD BEARING WALLS
- CROSS TIES IN E-W DIRECTION AT LOCATIONS OF SPLICED TOP PLATES OR BEAMS AT (E) WOOD BEARING WALLS. LOCATIONS TO BE FIELD VERIFIED.

- PLYWOOD AT (E) CRIPPLE WALL AT HIGH ROOF ATTIC
- PLYWOOD SPANNING FROM MAIN ROOF SHEATHING ABOVE TO CONCRETE WALL BELOW AT PERIMETER OF MAIN ROOF

Indicates location to remove ceiling to provide clear view of structure for inspection and measurement

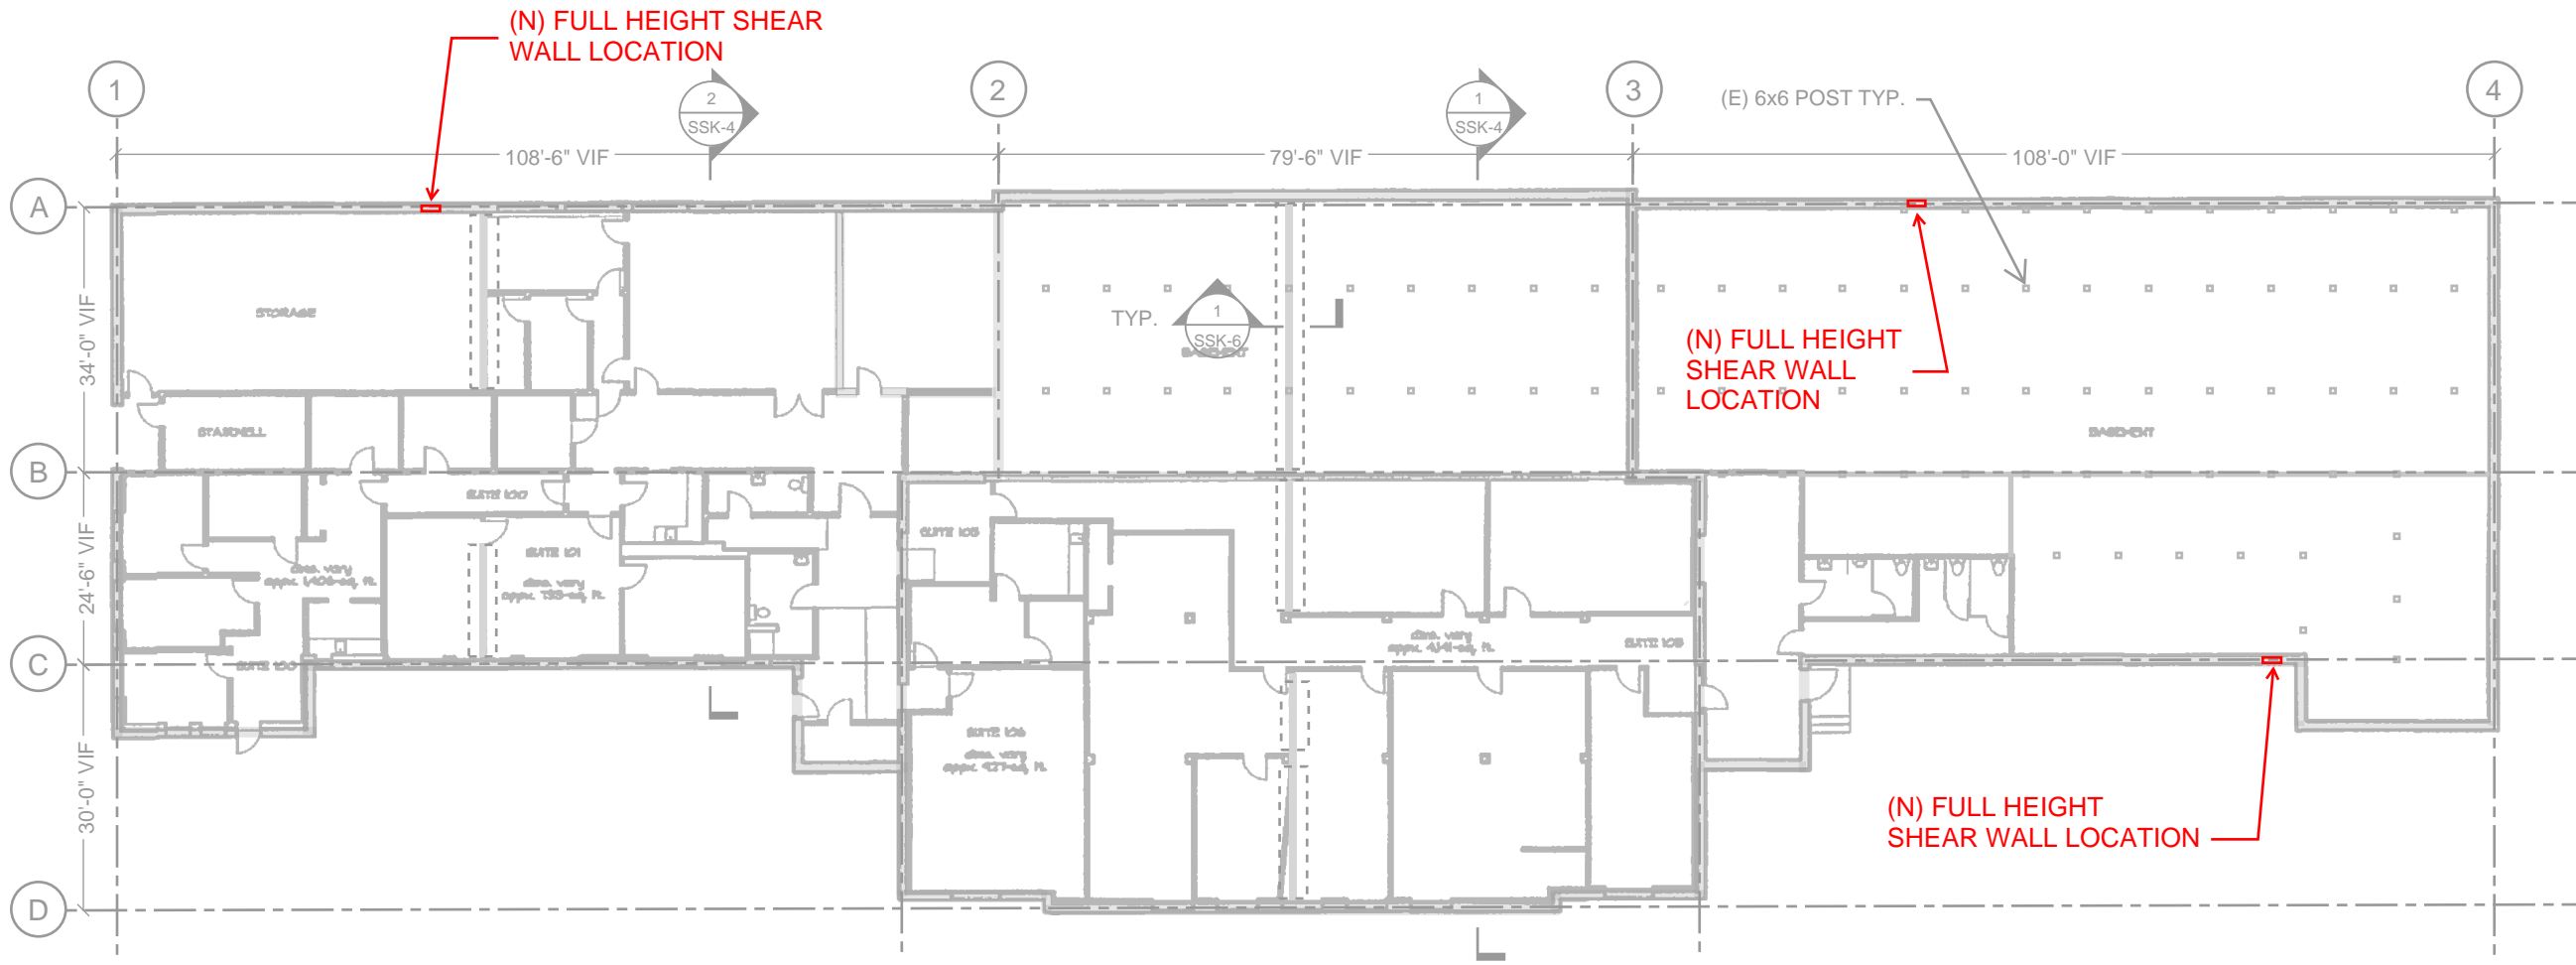
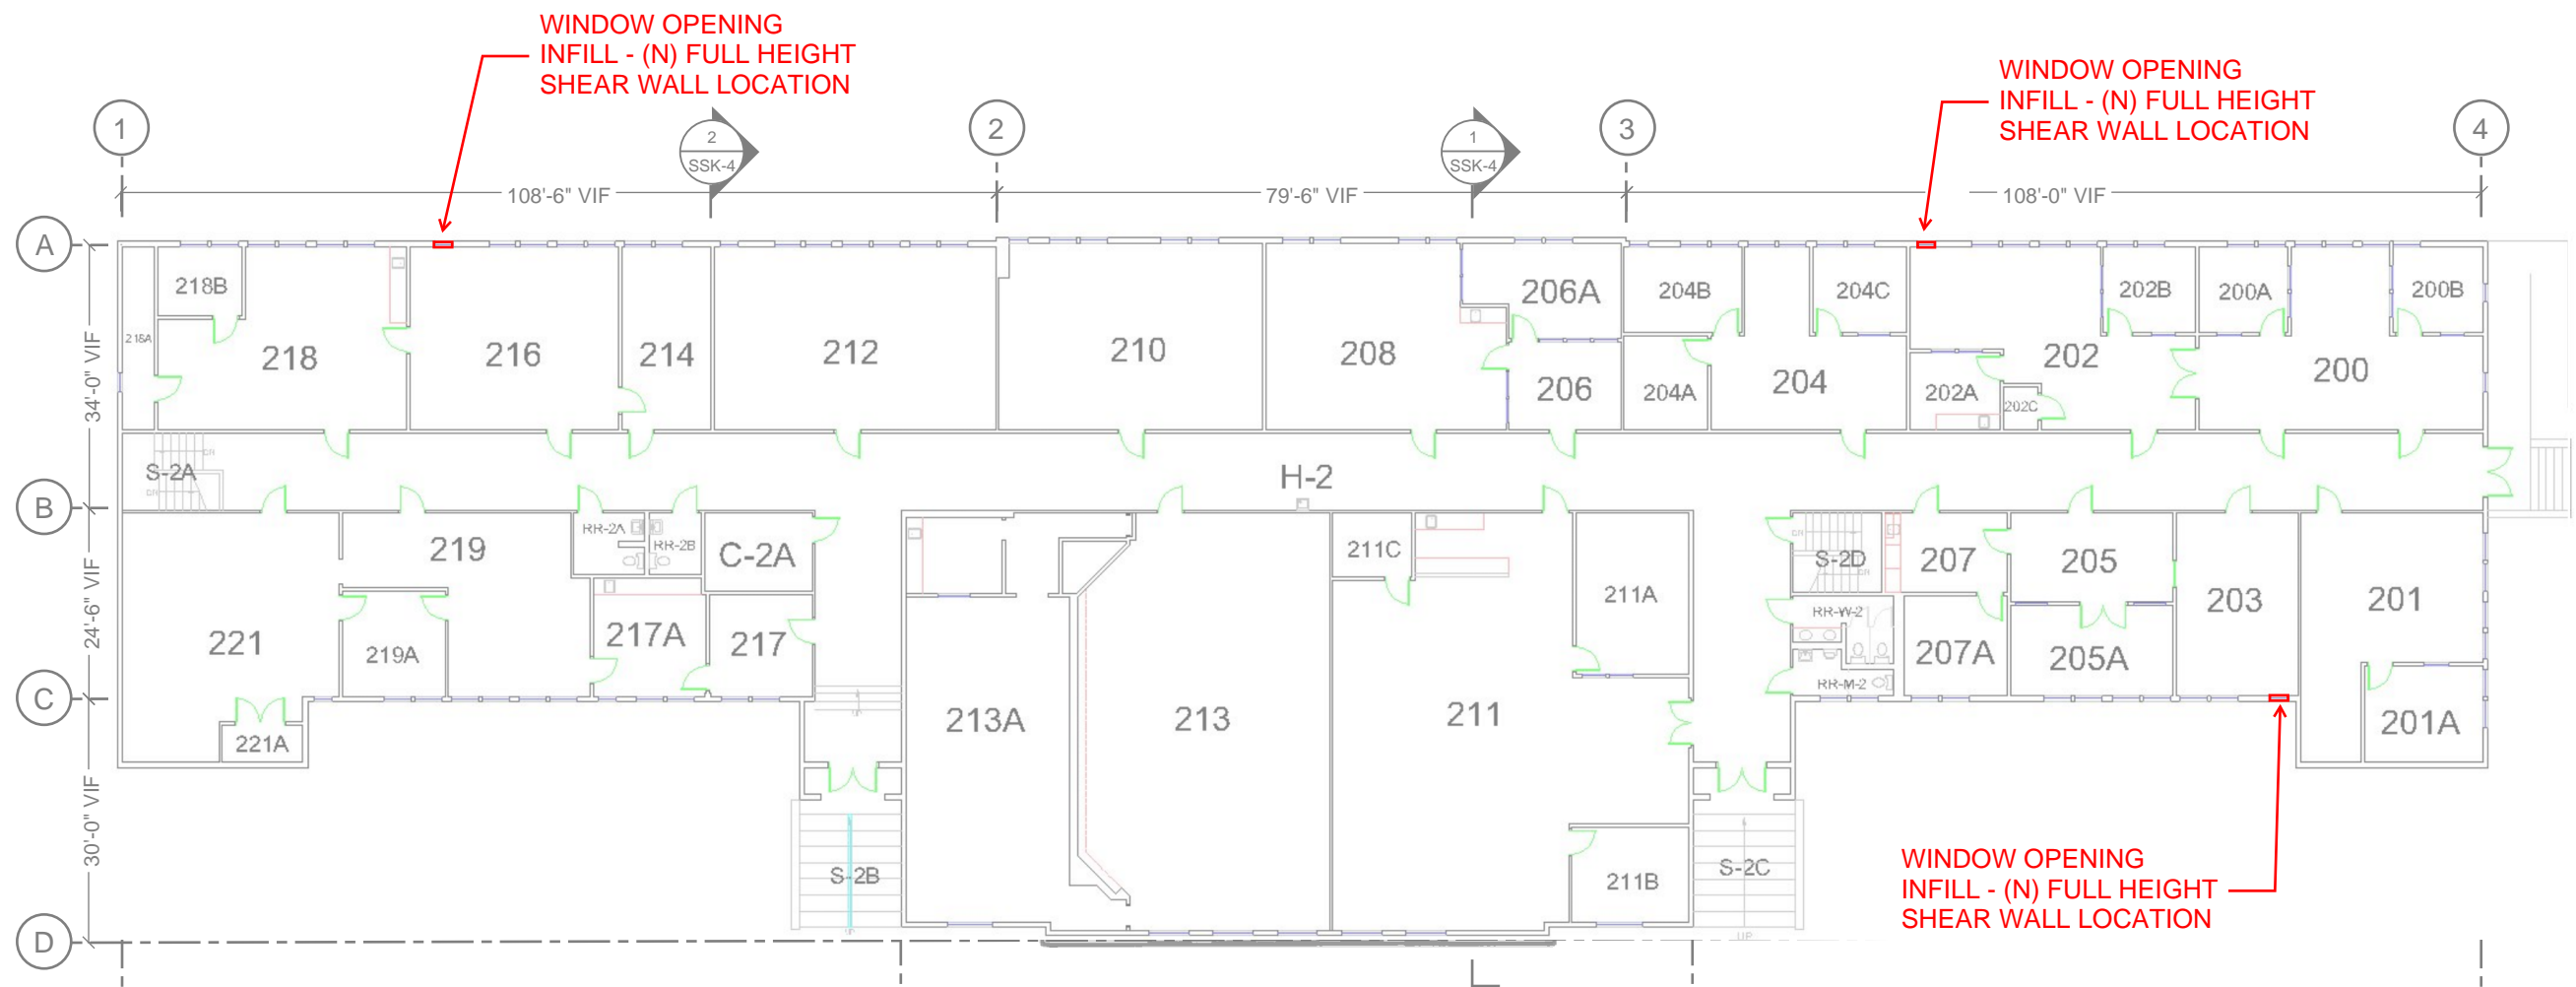
LEVEL 1
SCALE: NTS

POTENTIAL LOCATIONS FOR ADDED SHEAR AT BUILDING VERTICAL ENVELOPE

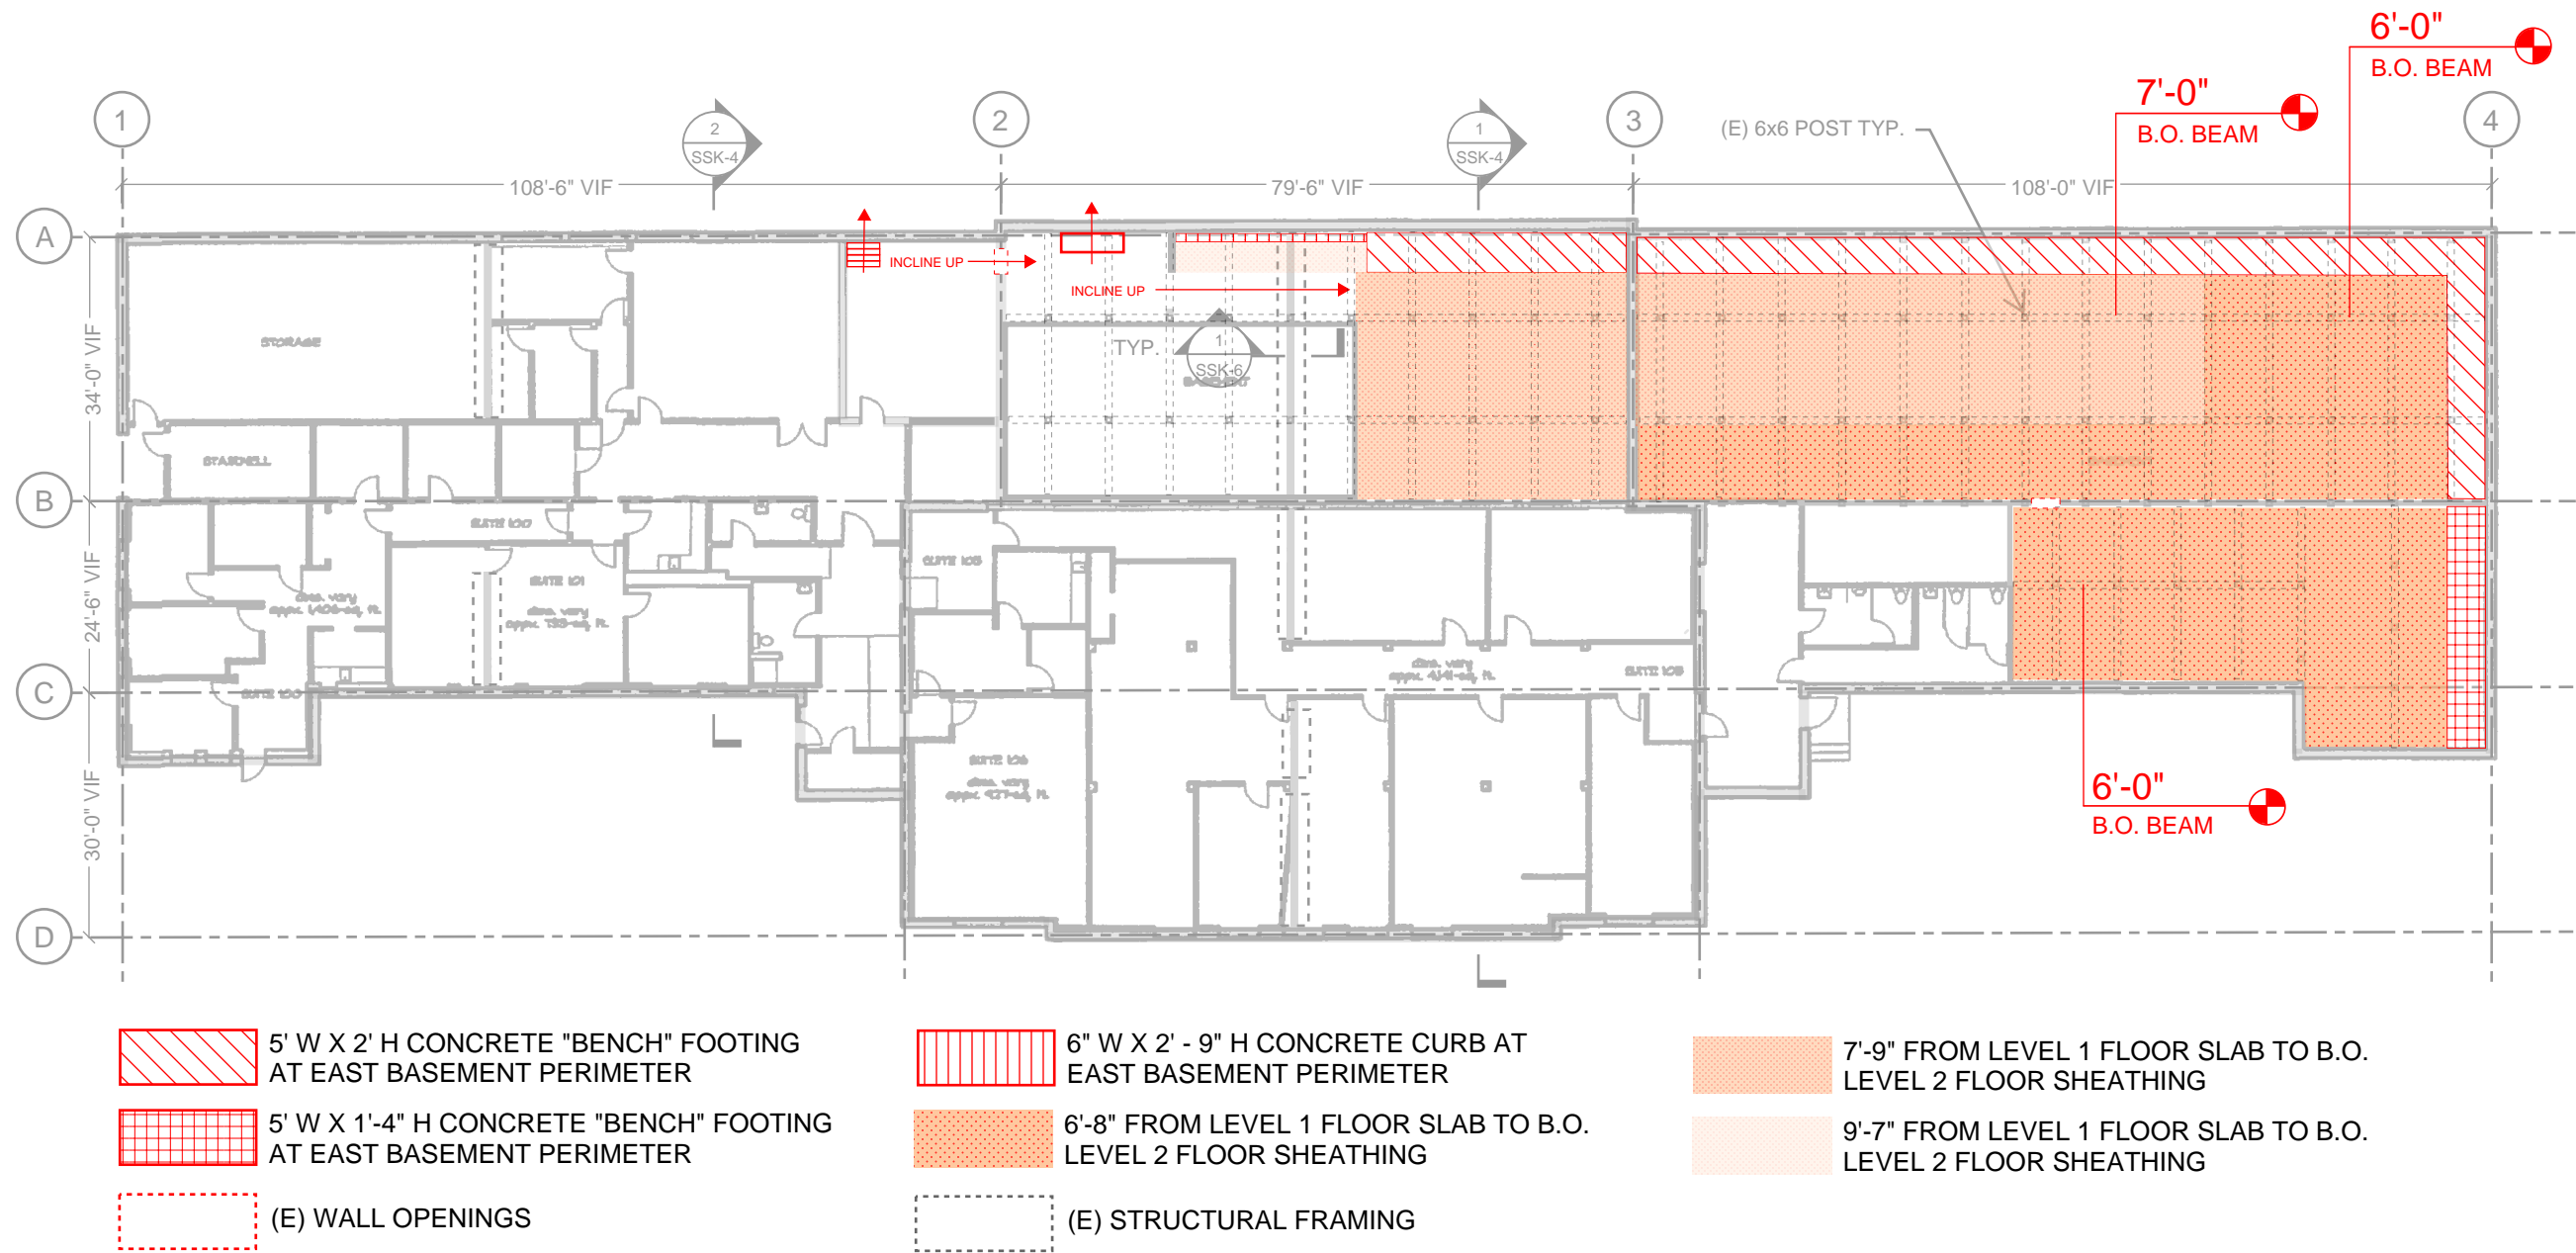
LEVEL 1
SCALE: NTS

STEWART BUILDING LEVEL 1 EAST WING "BASEMENT" SLAB ELEVATIONS
