Volume 6 Number 3 August 1974

**Use of Cattleguard Superstructures for Low Water
Crossings on Secondary Forest Roads**

USE OF CATTLEGUARD SUPERSTRUCTURES FOR LOW WATER CROSSINGS ON SECONDARY FOREST ROADS

By Steven A. Brink
Civil Engineer, Eldorado National Forest

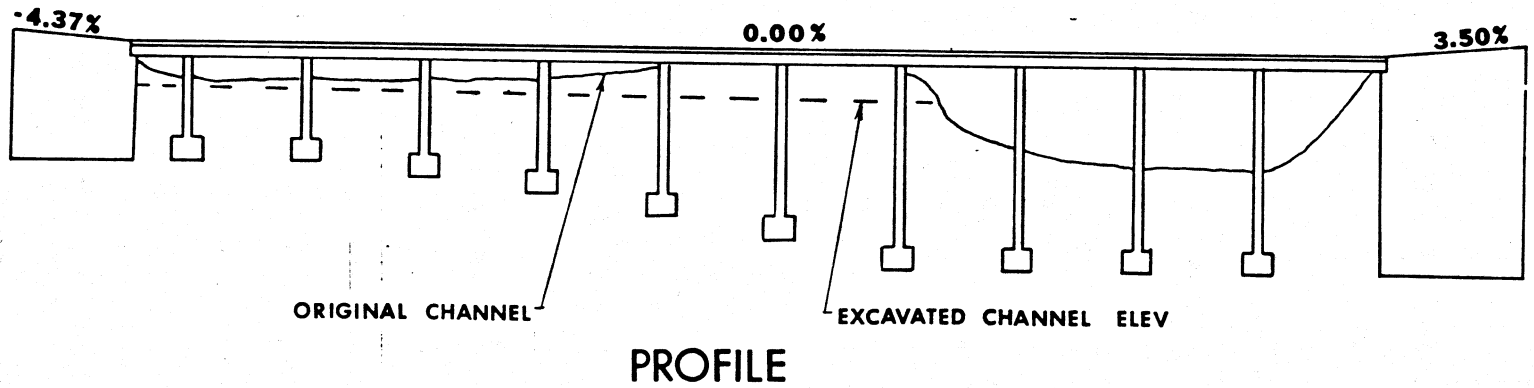
Figure 1. - Plan and Profile

suggested expanding a concept we had used before, that of a concrete ford with a single cattleguard over the low flow opening, to a “low-water bridge” structure with concrete piers and a cattleguard running surface (see fig. 1).
